SAFE SCHOOL PRECINCTS ENCOURAGING ACTIVE MOBILITY AMONG SCHOOLCHILDREN

VOLUME II – RESULTS FROM THE STAR RATING ANALYSIS OF SCHOOLS IN COIMBATORE, INDIA

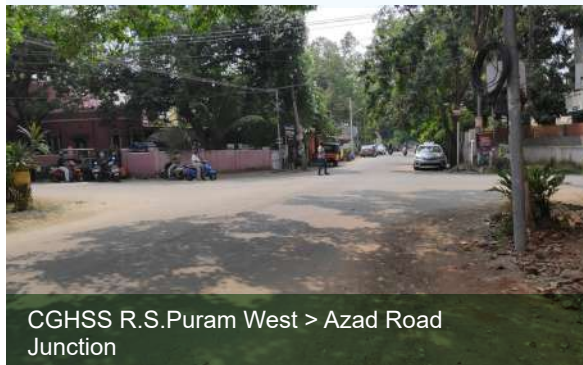
No sidewalk | No crossing facility

| 4-leg intersection

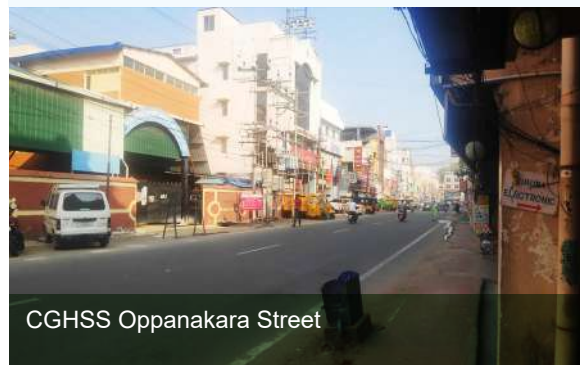
Informal sidewalk | No crossing facility

| Nonintersection

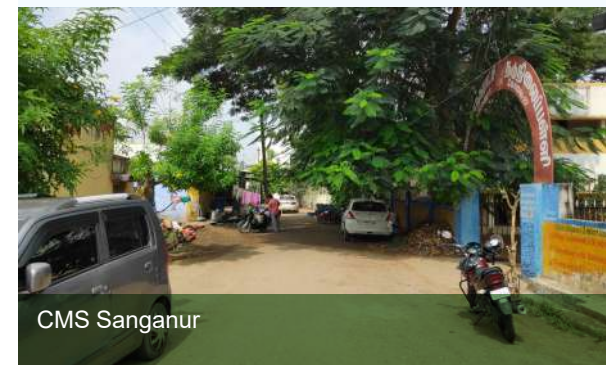
No sidewalk | No crossing facility | No intersection | Low speed | Low traffic volume
(This location achieved 3-star as speed and traffic volume are low)

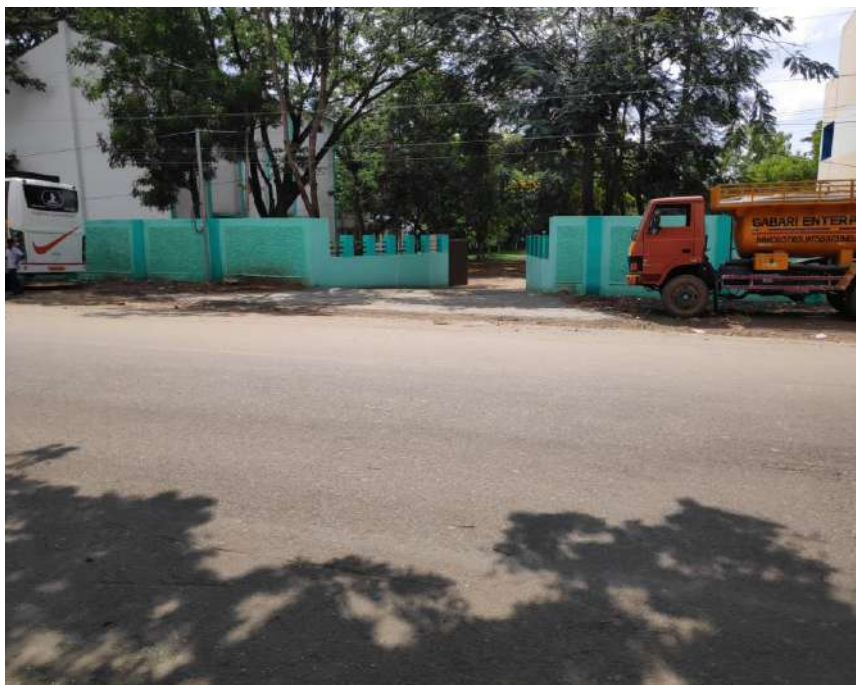
Star Rating Map

Road safety assessment was done at 2 locations. Star ratings for the locations are shown in the map and table.

Location No.	Location Name	Baseline Star Rating
1	Uppilipalayam Main Rd > School Entrance	★
2	Kamarajar Rd - Uppilipalayam Main Rd > Intersection	★

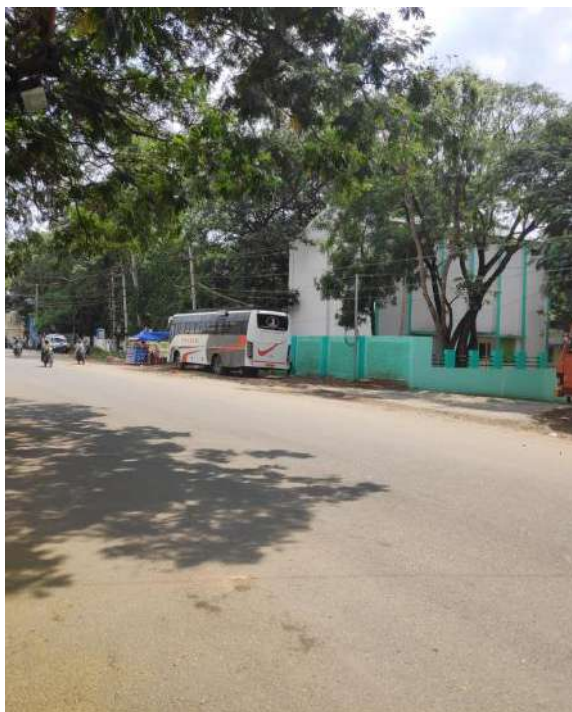
Road Attributes	Current Situation	Improvement Option-1	Improvement Option-2
Delineation and signages	Poor	Adequate	Adequate
Paved Shoulder right	Not present	Narrow	Narrow
Paved Shoulder left	Not present	Narrow	Narrow
Traffic calming	Not present	Present	Not present
Pedestrian crossing facility	No facility	Raised crossing	Marked crossing
Sidewalk left	Not present	Formal sidewalk	Formal sidewalk
Sidewalk right	Not present	Formal sidewalk	Formal sidewalk
Pedestrian fencing	Not present	Not present	Not present
Street lighting	Present	Present	Present
Road surface condition	Adequate	Adequate	Adequate
Intersection quality	NA	NA	NA
Vehicle parking	Both sides	Both sides	Both sides
STAR RATING	★	★★★★	★★★★
Star Rating Score	119.13	16.19	30.27

- No pedestrian crossing facility
- No footpath
- No speed calming measure
- Undivided road with centre-line median
- 4-leg intersection
- Poor road delineation and signages
- Moderate road surface condition

Option-2 shows the achievable star rating with table-top type crossing instead of signalised

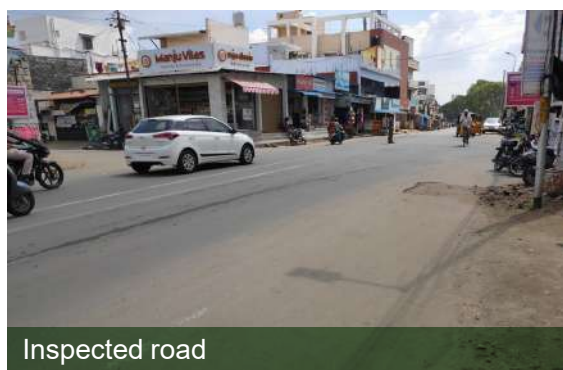
Existing Road Attributes and Improvement Options

Road Attributes	Current Situation	Improvement Option-1	Improvement Option-2
Delineation and signages	Poor	Adequate	Adequate
Paved shoulder right	Not present	Narrow	Narrow
Paved shoulder left	Not present	Narrow	Narrow
Traffic calming	Not present	Not present	Present
Pedestrian crossing facility	No facility	Signalised crossing	Raised crossing
Sidewalk left	Not present	Formal sidewalk	Formal sidewalk
Sidewalk right	Not present	Formal sidewalk	Formal sidewalk
Pedestrian fencing	Not present	Not present	Not present
Street lighting	Present	Present	Present
Road surface condition	Moderate	Adequate	Adequate
Intersection quality	Poor	Good	Good
Vehicle parking	One side	One side	One side
STAR RATING	★	★★★	★★★
Star Rating Score	374.93	28.41	38.74

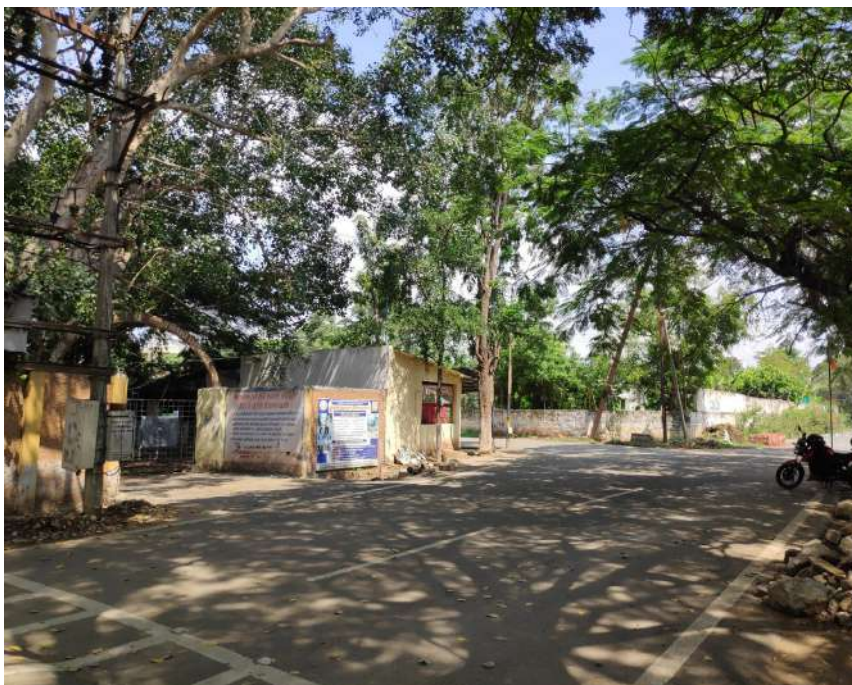
Star Rating Map

Road safety assessment was done at 2 locations. Star ratings for the locations are shown in the map and table.

Location No.	Location Name	Baseline Star Rating
1	Kallimadai Rd > School Entrance	★ ★
2	Kallimadai Rd > Intersection	★ ★

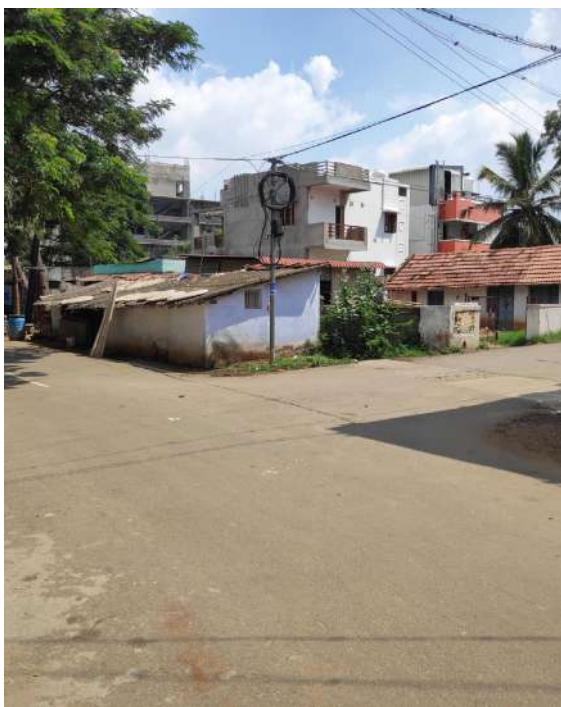
Existing Road Attributes and Improvement Options

Road Attributes	Current Situation	Improvement Option-1	Improvement Option-2
Delineation and signages	Poor	Adequate	Adequate
Paved shoulder right	Not present	Narrow	Narrow
Paved shoulder left	Not present	Narrow	Narrow
Traffic calming	Not present	Present	Not Present
Pedestrian crossing facility	No facility	Raised crossing	Marked crossing
Sidewalk left	Not present	Formal sidewalk	Formal sidewalk
Sidewalk right	Not present	Formal sidewalk	Formal sidewalk
Pedestrian fencing	Not present	Not present	Not present
Street lighting	Present	Present	Present
Road surface condition	Adequate	Adequate	Adequate
Intersection quality	Poor	Good	Good
Vehicle parking	One side	One side	One side
STAR RATING	★	★★★★	★★★★
Star Rating Score	59.83	7.63	14.28

Option-2 shows the achievable star rating with zebra marking instead of raised crossing

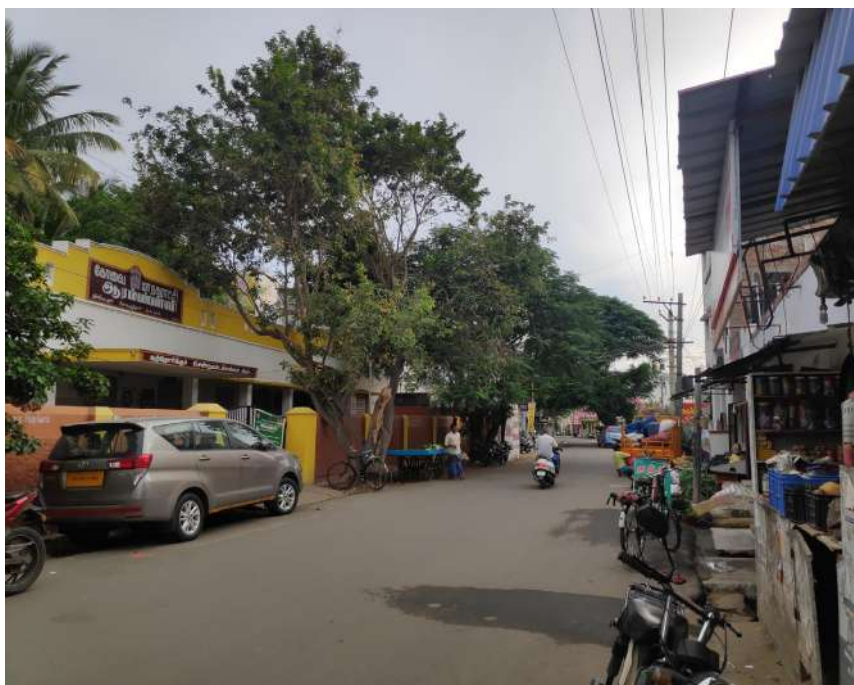
Star Rating Map

Road safety assessment was done at 3 locations. Star ratings for the locations are shown in the map and table.

Location No.	Location Name	Baseline Star Rating
1	Pudur Main Rd > School Entrance	★ ★
2	Pudur Main Rd > Intersection	★
3	Avinashi Rd - Pudur Main Rd > Intersection	★

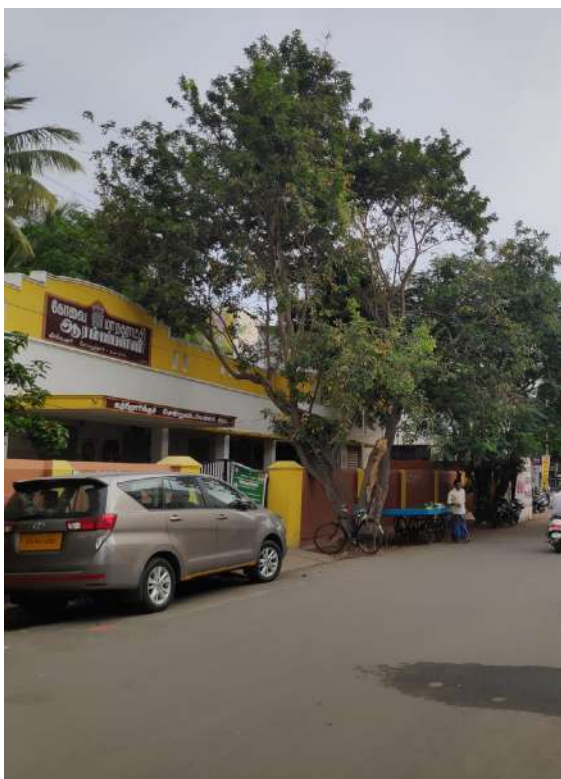
- No pedestrian crossing facility
- No footpath
- No speed calming measure
- Undivided road with centre-line median
- Medium road surface condition
- Poor road delineation and signages

Road Attributes	Current Situation	Improvement Option-1	Improvement Option-2
Delineation and signages	Poor	Adequate	Adequate
Paved shoulder right	Not present	Narrow	Narrow
Paved shoulder left	Not present	Narrow	Narrow
Traffic calming	Not present	Present	Not Present
Pedestrian crossing facility	No facility	Raised crossing	Marked crossing
Sidewalk left	Not present	Formal sidewalk	Formal sidewalk
Sidewalk right	Not present	Formal sidewalk	Formal sidewalk
Pedestrian fencing	Not present	Not present	Not present
Street lighting	Present	Present	Present
Road surface condition	Adequate	Adequate	Adequate
Intersection quality	NA	NA	NA
Vehicle parking	One side	One side	One side
STAR RATING	★	★★★★	★★★★
Star Rating Score	47.69	6.54	12.22

Suggested Safety Measures (option-1)

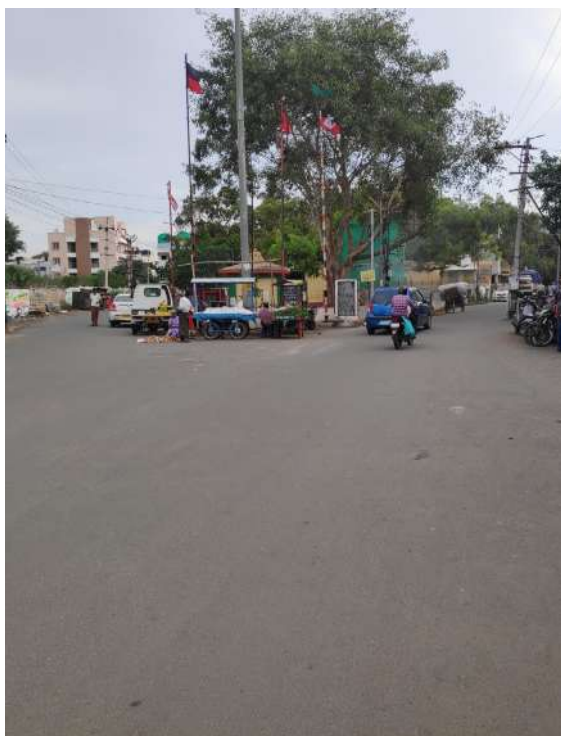
Existing Road Attributes and Improvement Options

Road Attributes	Current Situation	Improvement Option-1	Improvement Option-2
Delineation and signages	Poor	Adequate	Adequate
Paved shoulder right	Not present	Narrow	Narrow
Paved shoulder left	Not present	Narrow	Narrow
Traffic calming	Not present	Present	Not Present
Pedestrian crossing facility	No facility	Raised crossing	Marked crossing
Sidewalk left	Not present	Formal sidewalk	Formal sidewalk
Sidewalk right	Not present	Formal sidewalk	Formal sidewalk
Pedestrian fencing	Not present	Not present	Not present
Street lighting	Present	Present	Present
Road surface condition	Adequate	Adequate	Adequate
Intersection quality	Poor	Good	Good
Vehicle parking	One side	One side	One side
STAR RATING	★	★★★	★★★
Star Rating Score	126.5	19.03	35.61

Option-2 shows the achievable star rating with zebra marking instead of raised crossing

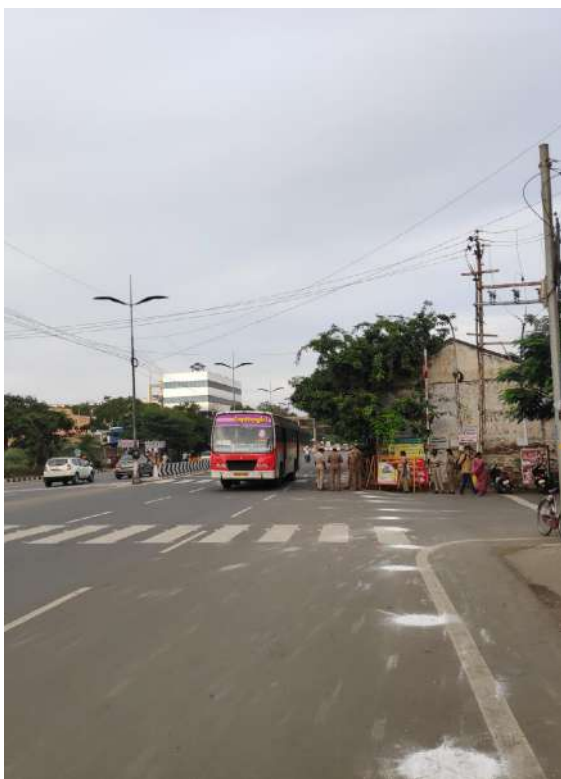
Existing Road Attributes and Improvement Options

Road Attributes	Current Situation	Improvement Option-1	Improvement Option-2
Delineation and signages	Adequate	Adequate	Adequate
Paved shoulder left	Miduam	Miduam	Miduam
Paved shoulder right	Narrow	Narrow	Narrow
Traffic calming	Not present	Not Present	Present
Pedestrian crossing facility	Marked crossing	Signalised crossing	Raised crossing
Sidewalk left	Informal sidewalk	Formal sidewalk	Formal sidewalk
Sidewalk right	Not present	Not present	Not present
Pedestrian fencing	Not present	Present	Present
Street lighting	Present	Present	Present
Road surface condition	Adequate	Adequate	Adequate
Intersection quality	Poor	Good	Good
Vehicle parking	One side	One side	One side
STAR RATING	★	★★★	★★
Star Rating Score	580.97	33.05	48.77

Option-2 shows the achievable star rating with table-top type crossing instead of signalized crossing

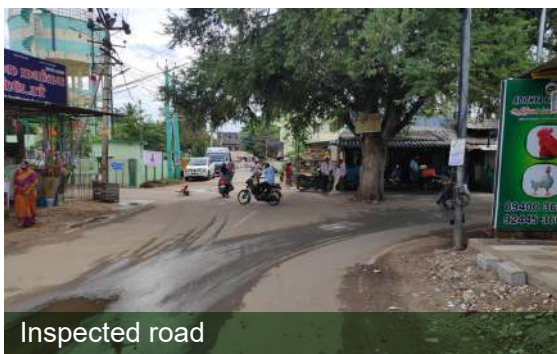
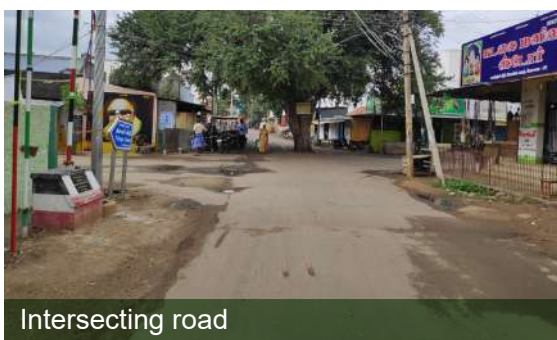
School No.	Location No.	Name of School	Location Name
4	1	CPS KOVILMEDU	Kovilmedu – Onampalayam > Intersection

- No pedestrian crossing facility
- No footpath
- Speed calming measure present
- Undivided road with centre-line median
- 4-leg intersection
- Poor road surface condition and delineation

- Road surface and delineation improvement with proper signages
- Raised (table-top type) pedestrian crossing facility with proper signages and marking on inspected road and intersecting road
- Formal and obstruction free sidewalk on both sides of the road
- Intersection quality improvement with proper signages and marking
- Narrow (<1m wide) paved shoulder (edge line marking)

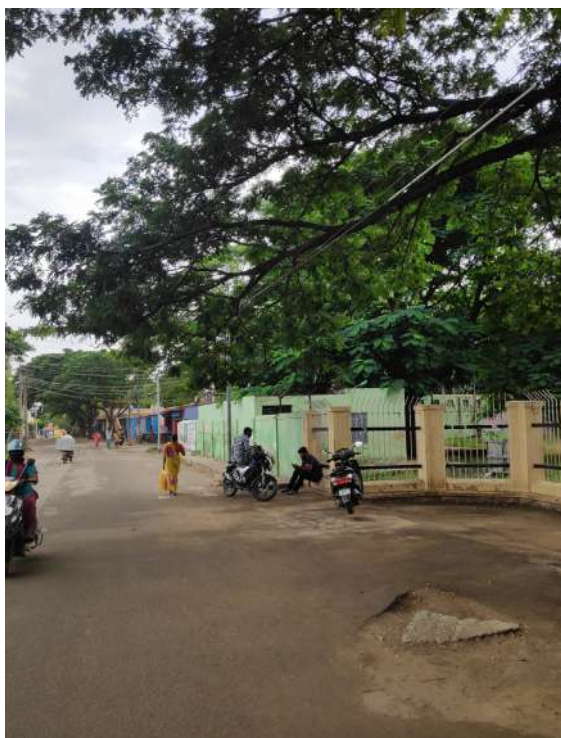
Existing Road Attributes and Improvement Options

- No pedestrian crossing facility
- Formal sidewalk on one side
- No speed calming measure
- Undivided road with centre-line median
- Moderate road surface condition
- Poor road delineation and signages

Road Attributes	Current Situation	Improvement Option-1	Improvement Option-2
Delineation and signages	Poor	Adequate	Adequate
Paved shoulder right	Not present	Narrow	Narrow
Paved shoulder left	Not present	Narrow	Narrow
Traffic calming	Not present	Present	Not present
Pedestrian crossing facility	No facility	Raised crossing	Marked crossing
Sidewalk left	Not present	Formal sidewalk	Formal sidewalk
Sidewalk right	Formal sidewalk	Formal sidewalk	Formal sidewalk
Pedestrian fencing	Not present	Not present	Not present
Street lighting	Present	Present	Present
Road surface condition	Moderate	Adequate	Adequate
Intersection quality	NA	NA	NA
Vehicle parking	One side	One side	One side
STAR RATING	★ ★ ★	★ ★ ★ ★ ★	★ ★ ★ ★ ★
Star Rating Score	25.72	4.18	7.81

Option-2 shows the achievable star rating with zebra marking instead of raised crossing

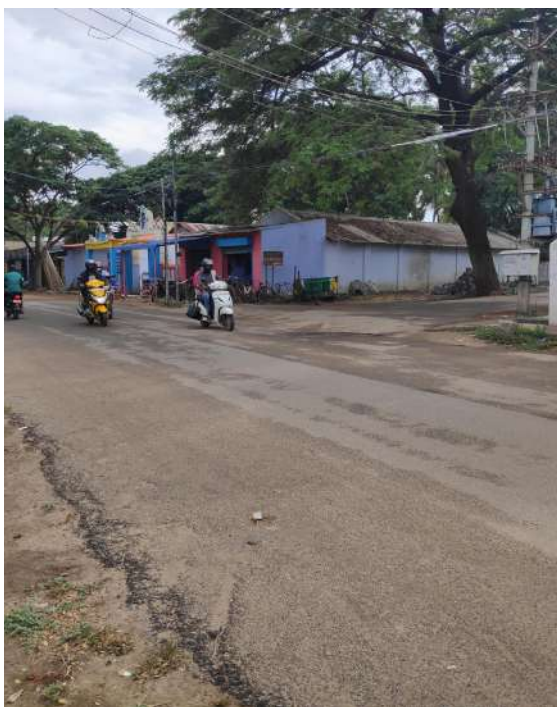
Existing Road Attributes and Improvement Options

Road Attributes	Current Situation	Improvement Option-1	Improvement Option-2
Delineation and signages	Poor	Adequate	Adequate
Paved shoulder right	Not present	Narrow	Narrow
Paved shoulder left	Not present	Narrow	Narrow
Traffic calming	Not present	Present	Not present
Pedestrian crossing facility	No facility	Raised crossing	Marked crossing
Sidewalk left	Not present	Formal sidewalk	Formal sidewalk
Sidewalk right	Not present	Formal sidewalk	Formal sidewalk
Pedestrian fencing	Not present	Not Present	Not present
Street lighting	Present	Present	Present
Road surface condition	Adequate	Adequate	Adequate
Intersection quality	Poor	Good	Good
Vehicle parking	One side	One side	One side
STAR RATING	★ ★	★ ★ ★ ★	★ ★ ★ ★
Star Rating Score	58.82	7.63	14.27

Option-2 shows the achievable star rating with zebra marking instead of raised crossing

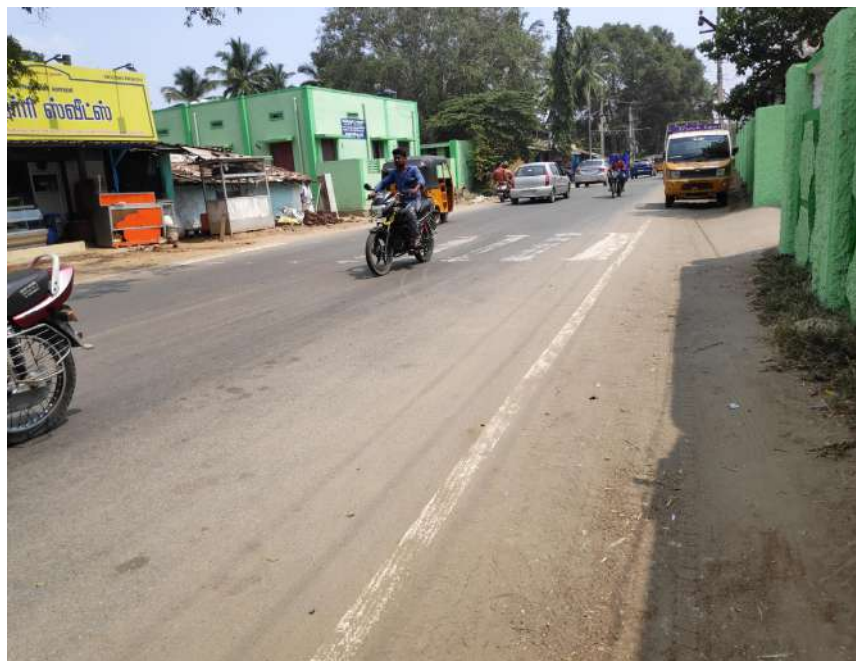
Star Rating Map

Road safety assessment was done at 2 locations. Star ratings for the locations are shown in the map and table.

Location No.	Location Name	Baseline Star Rating
1	Tagore Road > School entrance	★
2	Sangaralinganar Road - Tagore Road > Intersection	★

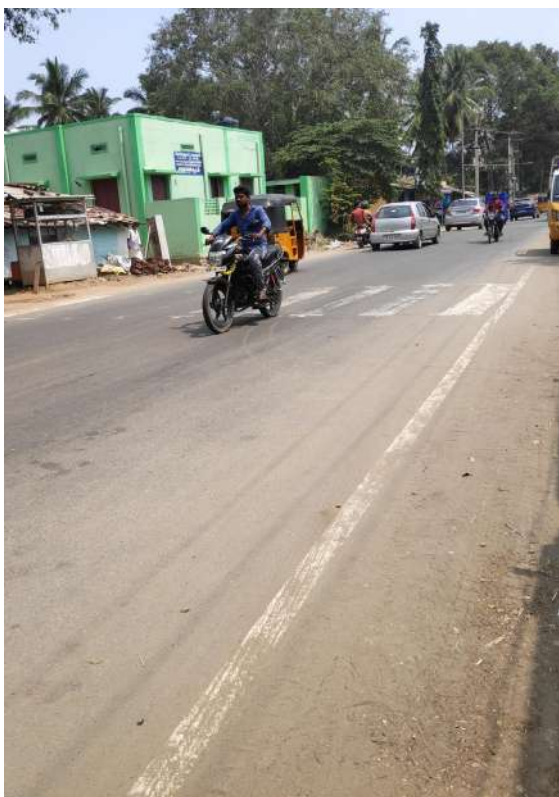
School No.	Location No.	Name of School	Location Name
5	1	CPS & CHS MANIYAKARANPALAYAM	Tagore Road > School entrance

- Marked pedestrian crossing facility
- Informal sidewalk
- No speed calming measure
- Undivided road with centre-line median
- Poor road delineation and signages

- Road surface and delineation improvement with proper signages including School Ahead sign
- Raised (table-top type) pedestrian crossing facility with proper signages and marking
- Formal and obstruction free sidewalk on both sides of the road
- Narrow (<1m wide) paved shoulder (edge line marking)

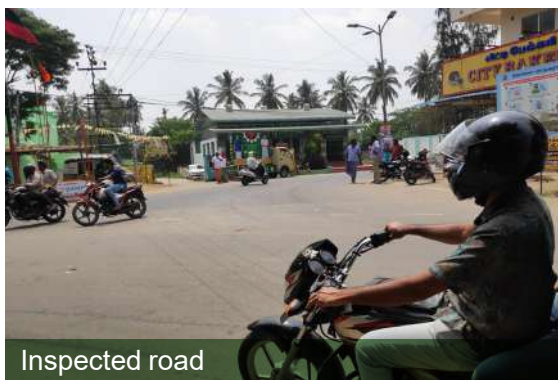
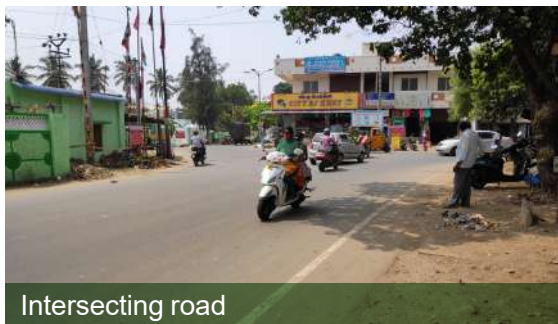
Inspected road

Intersecting road

- Road and curvature delineation improvement with proper signages including, warning signs, chevron signs and School Ahead sign
- Raised (table-top type) pedestrian crossing facility on inspected road and intersecting road
- Formal and obstruction free sidewalk on both sides of the road
- Intersection quality improvement with proper signages and marking
- Narrow (<1m wide) paved shoulder (edge line marking)

Option-2 shows the achievable star rating with zebra marking instead of raised crossing

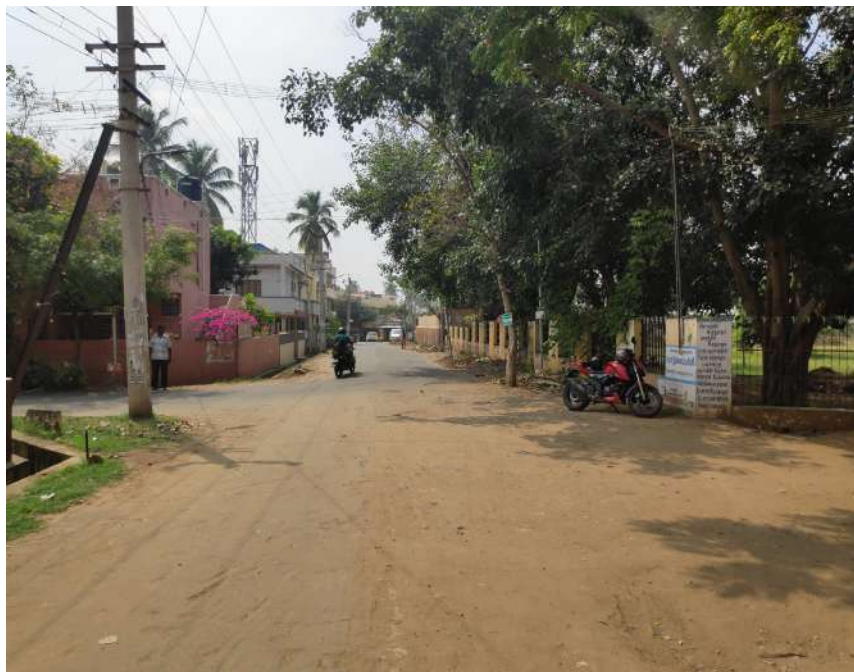
Star Rating Map

Road safety assessment was done at 2 locations. Star ratings for the locations are shown in the map and table.

Location No.	Location Name	Baseline Star Rating
1	Nallampalayam Road > Nallampalayam - School Road Junction	★
2	School Road > School Entrance	★★

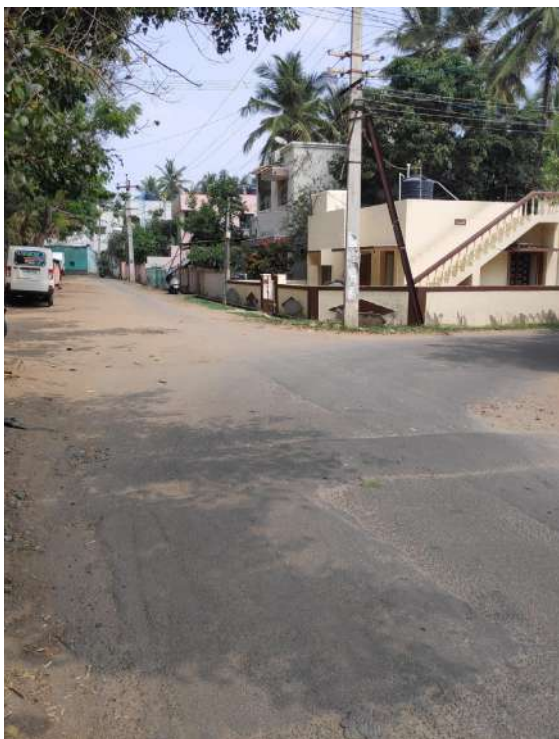
- No pedestrian crossing facility
- No footpath
- Speed calming measure present
- Undivided road with centre-line median
- 3-leg intersection
- Poor road delineation and signages
- Poor road surface condition

Road Attributes	Current Situation	Improvement Option-1	Improvement Option-2
Delineation and signages	Poor	Adequate	Adequate
Paved shoulder right	Not present	Narrow	Narrow
Paved shoulder left	Not present	Narrow	Narrow
Traffic calming	Present	Present	Present
Pedestrian crossing facility	No facility	Raised crossing	Marked crossing
Sidewalk left	Not present	Formal sidewalk	Formal sidewalk
Sidewalk right	Not present	Formal sidewalk	Formal sidewalk
Pedestrian fencing	Not present	Not Present	Not present
Street lighting	Present	Present	Present
Road surface condition	Poor	Adequate	Adequate
Intersection quality	Poor	Good	Good
Vehicle parking	One side	One side	One side
STAR RATING	★ ★	★ ★ ★ ★	★ ★ ★ ★
Star Rating Score	82.18	5.04	7.54

Suggested Safety Measures (option-1)

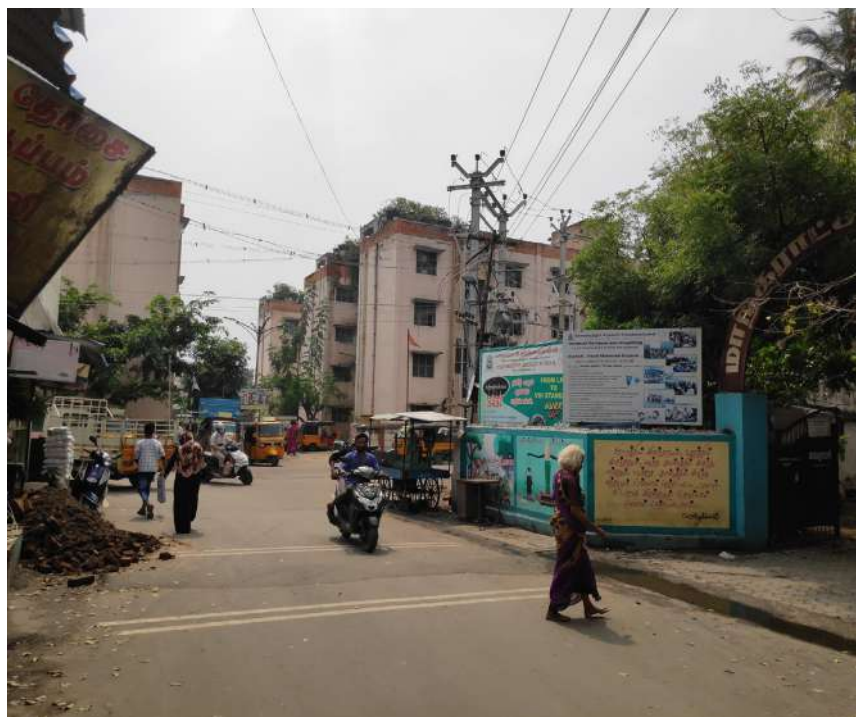
Star Rating Map

Road safety assessment was done at 2 locations. Star ratings for the locations are shown in the map and table.

Location No.	Location Name	Baseline Star Rating
1	Vincent Rd - Easwaran Koil St > Intersection	★
2	Eswaran Koil St - Lane St > Intersection	★★

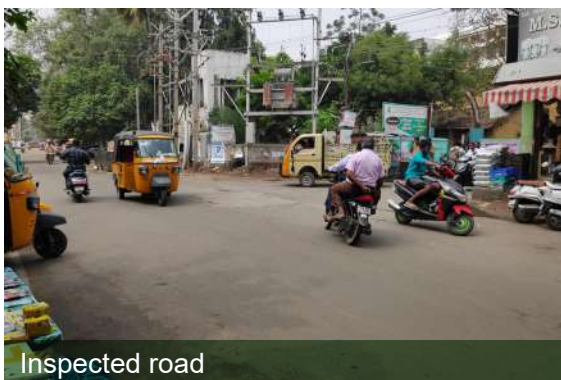
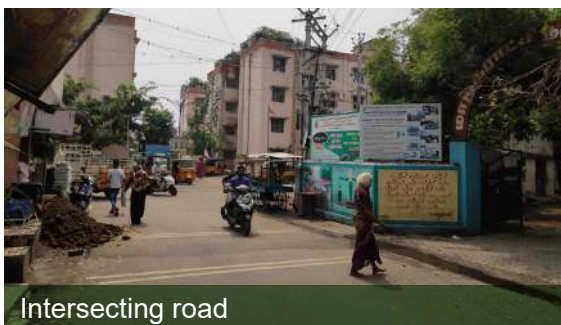
Location Description

- No pedestrian crossing facility
- No footpath
- No speed calming measure on inspected road
- Undivided road with centre-line median
- 4-leg intersection
- Poor road delineation and signages

Suggested Safety Measures (option-1)

- Road delineation improvement with proper signages including School Ahead sign
- Raised (table-top type) pedestrian crossing facility with proper signages and marking on inspected road and intersecting road
- Formal and obstruction free sidewalk on both sides of the road
- Intersection quality improvement with proper signages and marking
- Narrow (<1m wide) paved shoulder (edge line marking)

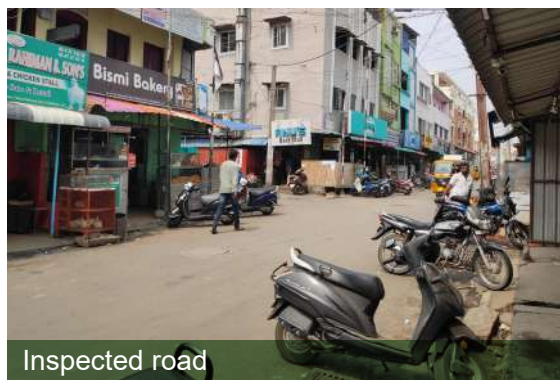
Existing Road Attributes and Improvement Options

Road Attributes	Current Situation	Improvement Option-1	Improvement Option-2
Delineation and signages	Poor	Adequate	Adequate
Paved shoulder right	Not present	Narrow	Narrow
Paved shoulder left	Not present	Narrow	Narrow
Traffic calming	Not present	Present	Not present
Pedestrian crossing facility	No facility	Raised crossing	Marked crossing
Sidewalk left	Not present	Formal sidewalk	Formal sidewalk
Sidewalk right	Not present	Formal sidewalk	Formal sidewalk
Pedestrian fencing	Not present	Not present	Not present
Street lighting	Present	Present	Present
Road surface condition	Adequate	Adequate	Adequate
Intersection quality	Poor	Good	Good
Vehicle parking	Both sides	Both sides	Both sides
STAR RATING	★ ★	★ ★ ★ ★	★ ★ ★
Star Rating Score	63.41	9.15	17.13

Option-2 shows the achievable star rating with zebra marking instead of raised crossing

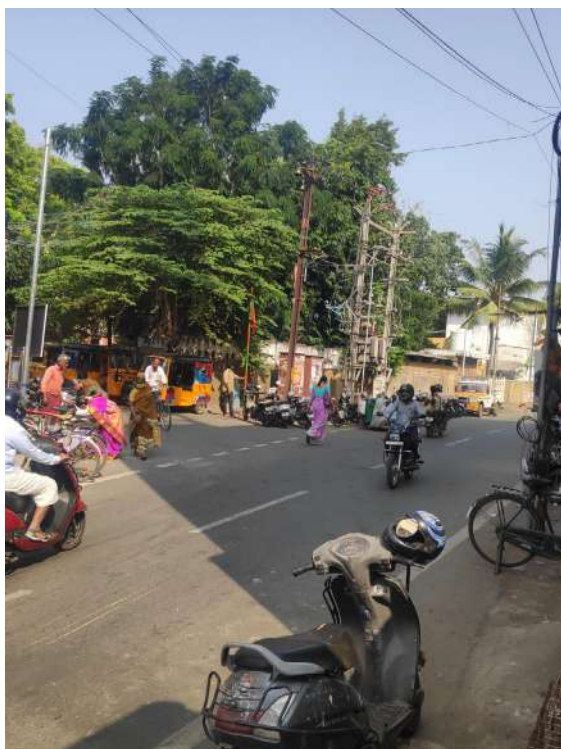
Existing Road Attributes and Improvement Options

Road Attributes	Current Situation	Improvement Option-1	Improvement Option-2
Delineation and signages	Adequate	Adequate	Adequate
Paved shoulder right	Narrow	Narrow	Narrow
Paved shoulder left	Narrow	Narrow	Narrow
Traffic calming	Not present	Present	Not present
Pedestrian crossing facility	No facility	Raised crossing	Marked crossing
Sidewalk left	Not present	Formal sidewalk	Formal sidewalk
Sidewalk right	Not present	Formal sidewalk	Formal sidewalk
Pedestrian fencing	Not present	Not present	Not present
Street lighting	Present	Present	Present
Road surface condition	Adequate	Adequate	Adequate
Intersection quality	Poor	Good	Good
Vehicle parking	One side	One side	One side
STAR RATING	★	★★★	★★★
Star Rating Score	106.3	15.92	29.79

Option-2 shows the achievable star rating with zebra marking instead of raised crossing

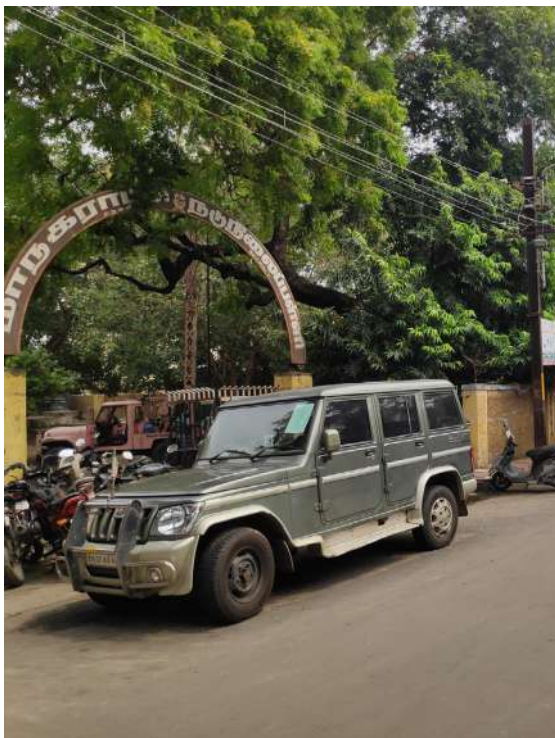
Existing Road Attributes and Improvement Options

- No pedestrian crossing facility
- No footpath
- No speed calming measure
- Undivided road with centre-line median
- Medium road surface condition
- Poor road delineation and signages

Road Attributes	Current Situation	Improvement Option-1	Improvement Option-2
Delineation and signages	Poor	Adequate	Adequate
Paved shoulder right	Not present	Narrow	Narrow
Paved shoulder left	Not present	Narrow	Narrow
Traffic calming	Not present	Present	Not present
Pedestrian crossing facility	No facility	Raised crossing	Marked crossing
Sidewalk left	Not present	Formal sidewalk	Formal sidewalk
Sidewalk right	Not present	Formal sidewalk	Formal sidewalk
Pedestrian fencing	Not present	Not Present	Not present
Street lighting	Present	Present	Present
Road surface condition	Adequate	Adequate	Adequate
Intersection quality	NA	NA	NA
Vehicle parking	Both sides	Both sides	Both sides
STAR RATING	★ ★ ★	★ ★ ★ ★ ★	★ ★ ★ ★ ★
Star Rating Score	25.38	3.30	6.18

Option-2 shows the achievable star rating with zebra marking instead of raised crossing

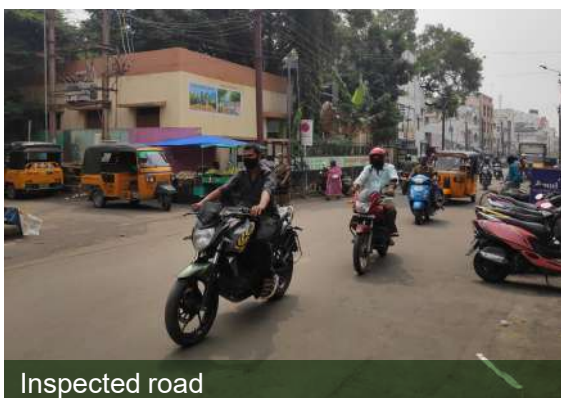
Inspected road

- No pedestrian crossing facility
- No footpath
- No speed calming measure
- Undivided road with centre-line median
- 3-leg intersection
- Poor road delineation and signages

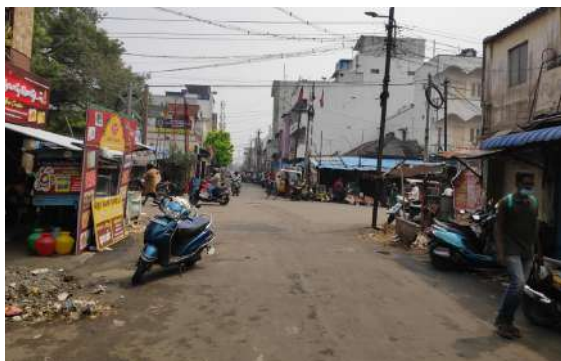
Existing Road Attributes and Improvement Options

Road Attributes	Current Situation	Improvement Option-1	Improvement Option-2
Delineation and signages	Poor	Adequate	Adequate
Paved shoulder right	Not present	Narrow	Narrow
Paved shoulder left	Not present	Narrow	Narrow
Traffic calming	Not present	Present	Not present
Pedestrian crossing facility	No facility	Signalised crossing	Raised crossing
Sidewalk left	Not present	Formal sidewalk	Formal sidewalk
Sidewalk right	Not present	Formal sidewalk	Formal sidewalk
Pedestrian fencing	Not present	Not present	Not present
Street lighting	Present	Present	Present
Road surface condition	Adequate	Adequate	Adequate
Intersection quality	Poor	Good	Good
Vehicle parking	One side	One sides	One side
STAR RATING	★	★★★	★★
Star Rating Score	256.86	22.74	48.44

Option-2 shows the achievable star rating with zebra marking instead of raised crossing

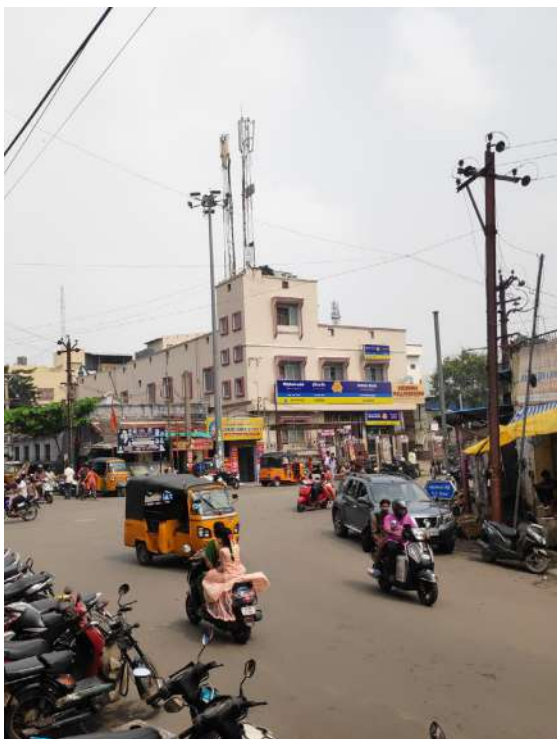
Existing Road Attributes and Improvement Options

Road Attributes	Current Situation	Improvement Option-1	Improvement Option-2
Delineation and signages	Poor	Adequate	Adequate
Paved shoulder right	Not present	Narrow	Narrow
Paved shoulder left	Not present	Narrow	Narrow
Traffic calming	Not present	Present	Not present
Pedestrian crossing facility	No facility	Signalised crossing	Raised crossing
Sidewalk left	Not present	Formal sidewalk	Formal sidewalk
Sidewalk right	Not present	Formal sidewalk	Formal sidewalk
Pedestrian fencing	Not present	Not Present	Not present
Street lighting	Present	Present	Present
Road surface condition	Adequate	Adequate	Adequate
Intersection quality	Poor	Good	Good
Vehicle parking	One side	One side	One side
STAR RATING	★	★★★	★★
Star Rating Score	389.19	32.10	68.39

Option-2 shows the achievable star rating with table-top type crossing instead of signalized

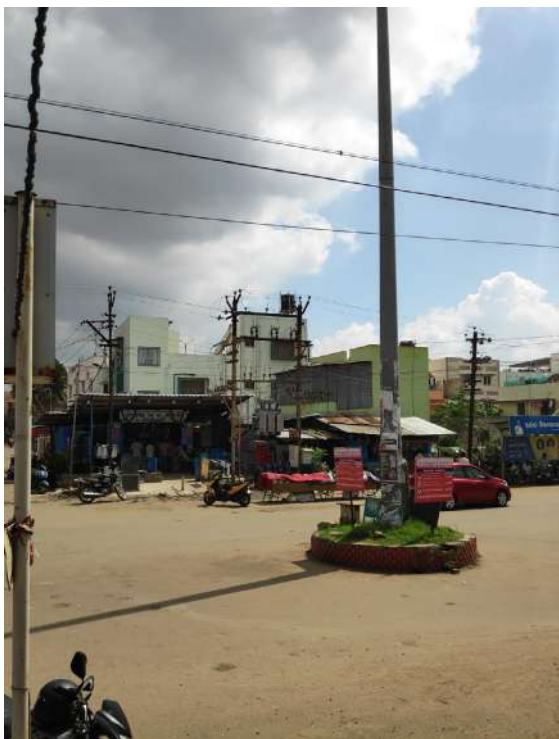
Existing Road Attributes and Improvement Options

Road Attributes	Current Situation	Improvement Option-1	Improvement Option-2
Delineation and signages	Poor	Adequate	Adequate
Paved shoulder right	Not present	Narrow	Narrow
Paved shoulder left	Not present	Narrow	Narrow
Traffic calming	Not present	Present	Not present
Pedestrian crossing facility	No facility	Raised crossing	Marked crossing
Sidewalk left	Not present	Formal sidewalk	Formal sidewalk
Sidewalk right	Not present	Formal sidewalk	Formal sidewalk
Pedestrian fencing	Not present	Not Present	Not present
Street lighting	Present	Present	Present
Road surface condition	Adequate	Adequate	Adequate
Intersection quality	Poor	Good	Good
Vehicle parking	Both sides	Both sides	Both sides
STAR RATING	★	★★★	★★★
Star Rating Score	171.01	20.55	38.48

Option-2 shows the achievable star rating with zebra marking instead of raised crossing

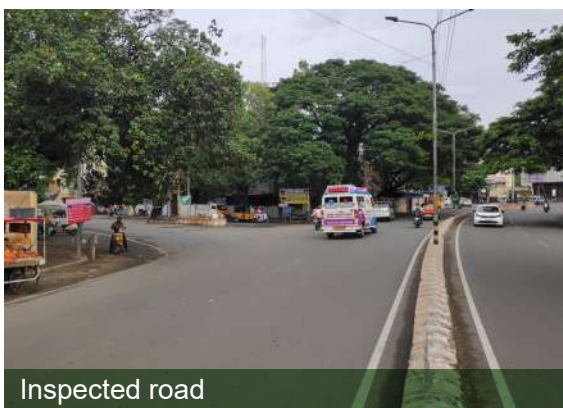
Inspected road

- No pedestrian crossing facility
- Informal footpath
- No speed calming measure
- Divided road with 2+2 lanes
- 3-leg intersection
- Poor road delineation and signages

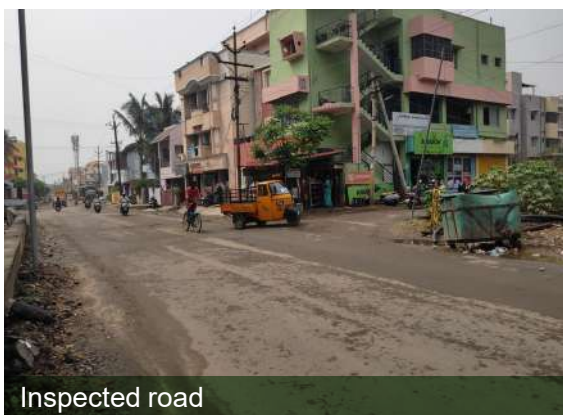
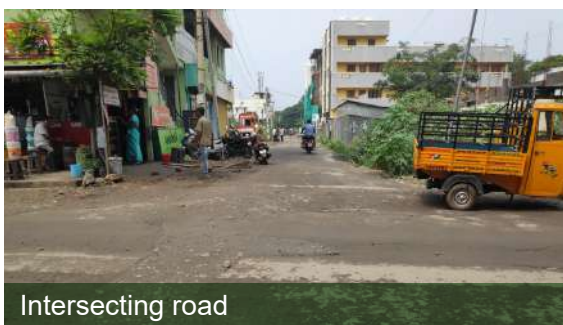
Location Description

- No pedestrian crossing facility
- No footpath
- No speed calming measure
- Undivided road with centre-line median
- 3-leg intersection
- Moderate road surface condition
- Poor road delineation and signages

Suggested Safety Measures (option-1)

- Road surface and delineation improvement with proper signages including School Ahead sign
- Raised (table-top type) pedestrian crossing facility with proper signages and marking on inspected road and intersecting road
- Formal and obstruction free sidewalk on both sides of the road
- Intersection quality improvement with proper signages and marking
- Narrow (<1m wide) paved shoulder (edge line marking)

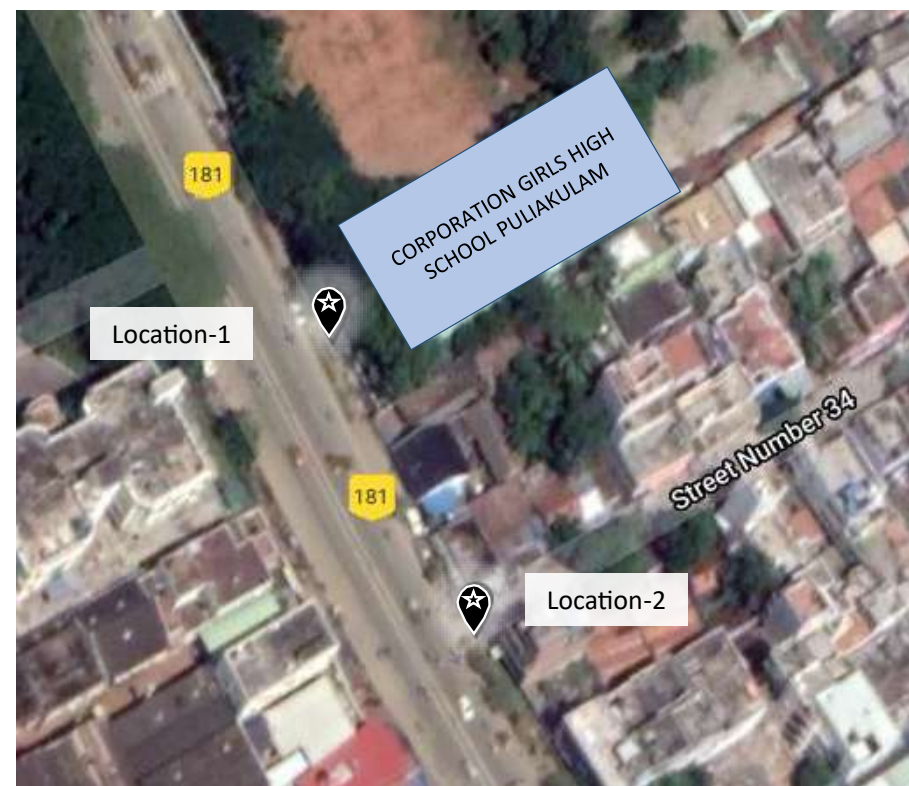
Star Rating Map

Location No.	Location Name	Baseline Star Rating
1	Puliakulam Rd > School Entrance	★
2	Puliakulam Rd - Street Number 34 > Intersection	★

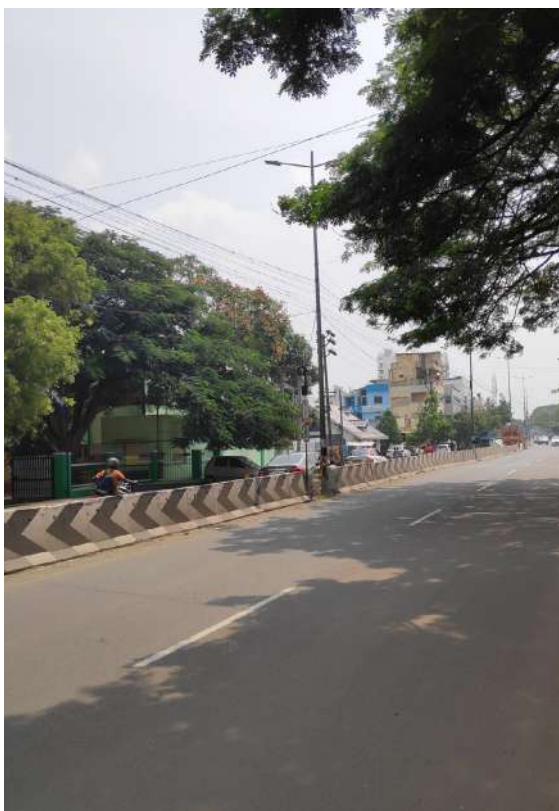
School No.	Location No.	Name of School	Location Name
14	1	CORPORATION GIRLS HIGH SCHOOL PULIAKULAM	Puliakulam Rd > School Entrance

- Signalized pedestrian crossing facility with proper signages and marking
- Formal and obstruction free sidewalk with pedestrian fencing
- Medium (1-2.4m wide) paved shoulder (edge line marking)
- School Ahead sign

Option-2 shows the achievable star rating with Table-top type crossing instead of signalised

Road Attributes	Current Situation	Improvement Option-1	Improvement Option-2
Delineation and signages	Adequate	Adequate	Adequate
Paved shoulder right	Narrow	Medium	Medium
Paved shoulder left	Narrow	Narrow	Narrow
Traffic calming	Present	Present	Present
Pedestrian crossing facility	No facility	Signalised crossing	Raised crossing
Sidewalk left	Informal sidewalk	Formal sidewalk	Formal sidewalk
Sidewalk right	Not present	Not present	Not present
Pedestrian fencing	Not present	Present	Present
Street lighting	Present	Present	Present
Road surface condition	Adequate	Adequate	Adequate
Intersection quality	NA	NA	NA
Vehicle parking	One side	One side	One side
STAR RATING	★	★★★★	★★★
Star Rating Score	107.09	8.60	21.66

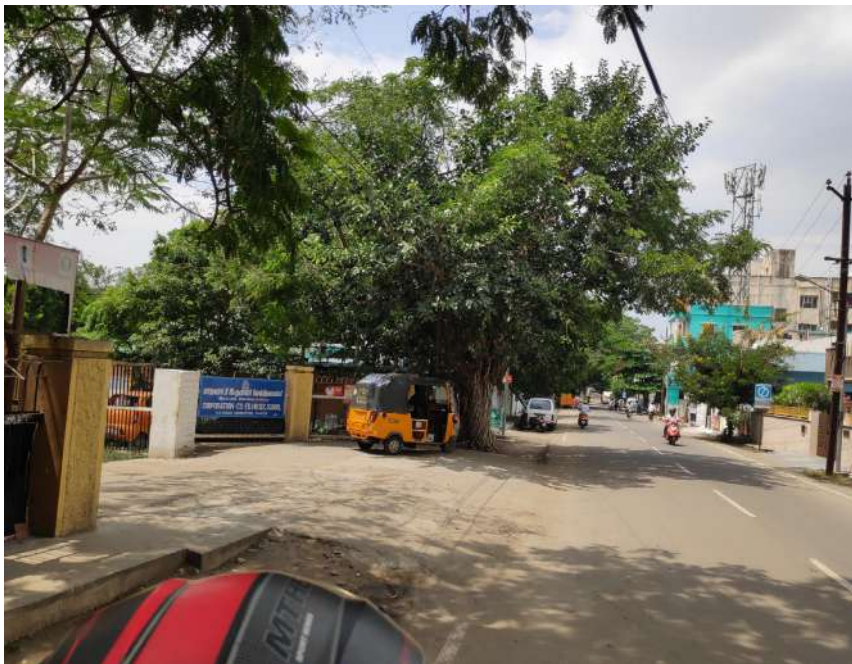
Star Rating Map

The road safety assessment of 3 locations are shown in the star rating map and details are given in the table.

Location No.	Location Name	Baseline Star Rating
1	Arokiasamy Rd W > School Entrance	★
2	Thadagam Main Rd – Arokiasamy Rd W > Intersection	★
3	Arokiasamy Rd W – Azad Rd > Intersection	★

SR4S assessment shows potential to improve pedestrian infrastructure at each of the locations. Details of existing infrastructure conditions and improvement options showing suggested safety measures and achievable star rating for each of the locations are presented in the following pages.

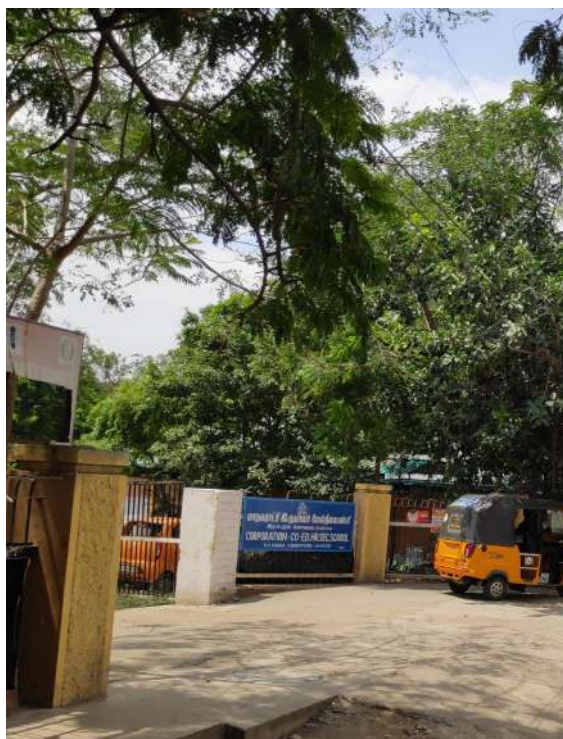
School No.	Location No.	Name of School	Location Name
15	2	CORPORATION HIGHER SECONDARY SCHOOL R.S. PURAM	Thadagam Main Rd – Arokiasamy Rd W > Intersection

Road Attributes	Current Situation	Improvement Option-1	Improvement Option-2
Delineation and signages	Adequate	Adequate	Adequate
Paved shoulder left	Narrow	Medium	Medium
Paved shoulder right	Narrow	Narrow	Narrow
Traffic calming	Not present	Not present	Present
Pedestrian crossing facility	No facility	Signalised crossing	Raised crossing
Sidewalk left	Not present	Formal sidewalk	Formal sidewalk
Sidewalk right	Not present	Not present	Not present
Pedestrian fencing	Not present	Present	Present
Street lighting	Present	Present	Present
Road surface condition	Adequate	Adequate	Adequate
Intersection quality	Poor	Good	Good
Vehicle parking	One side	One side	One side
STAR RATING	★	★★★	★★
Star Rating Score	367.82	37.90	48.38

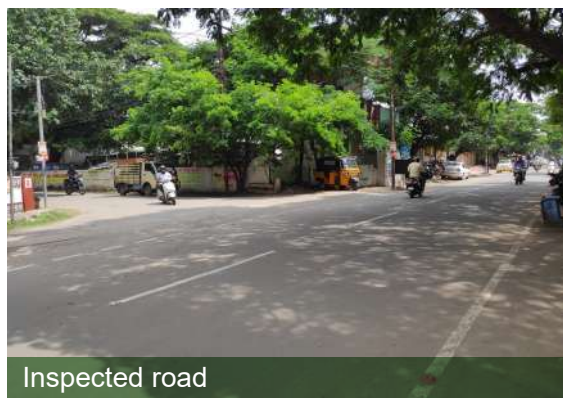
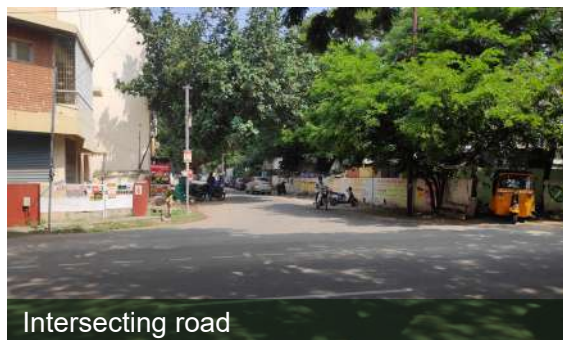
Inspected road

School No.	Location No.	Name of School	Location Name
15	3	CORPORATION HIGHER SECONDARY SCHOOL R.S. PURAM	Arokiasamy Rd W - Azad Rd > Intersection

- Raised (table-top type) pedestrian crossing facility with proper signages and marking on inspected road and intersecting road
- Formal and obstruction free sidewalk on both sides of the road
- Intersection quality improvement with proper signages and marking
- Medium (1-2.4m wide) paved shoulder (edge line marking)
- School Ahead sign

Option-2 shows the achievable star rating with zebra marking instead of raised crossing

Road Attributes	Current Situation	Improvement Option-1	Improvement Option-2
Delineation and signages	Adequate	Adequate	Adequate
Paved shoulder right	Narrow	Medium	Medium
Paved shoulder left	Narrow	Medium	Medium
Traffic calming	Not present	Present	Not present
Pedestrian crossing facility	No facility	Raised crossing	Marked crossing
Sidewalk left	Not present	Formal sidewalk	Formal sidewalk
Sidewalk right	Not present	Formal sidewalk	Formal sidewalk
Pedestrian fencing	Not present	Not present	Not present
Street lighting	Present	Present	Present
Road surface condition	Adequate	Adequate	Adequate
Intersection quality	Poor	Good	Good
Vehicle parking	Both sides	Both sides	Both sides
STAR RATING	★	★★★	★★
Star Rating Score	209.16	30.96	57.95

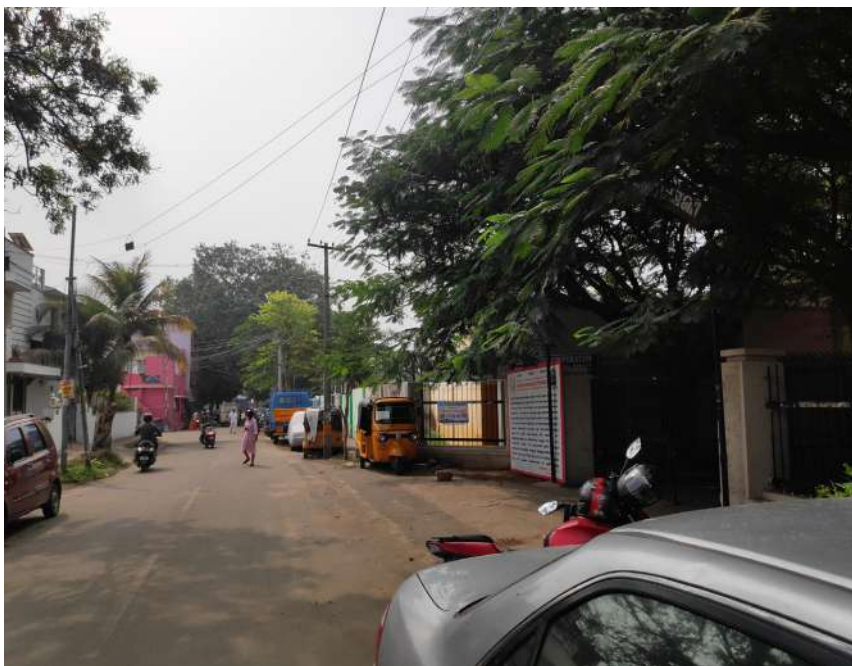
Star Rating Map

The road safety assessment of 3 locations are shown in the star rating map and details are given in the table.

Location No.	Location Name	Baseline Star Rating
1	Trichy Rd - Subramaniam St > Intersection	★
2	Subramaniam St > School Entrance	★★★
3	Subramaniam St - Street Number 53 > Intersection	★★

SR4S assessment shows potential to improve pedestrian infrastructure at each of the locations. Details of existing infrastructure conditions and improvement options showing suggested safety measures and achievable star rating for each of the locations are presented in the following pages.
