SAFE SCHOOL PRECINCTS ENCOURAGING ACTIVE MOBILITY AMONG SCHOOLCHILDREN

VOLUME II – RESULTS FROM THE STAR RATING ANALYSIS OF SCHOOLS IN COIMBATORE, INDIA

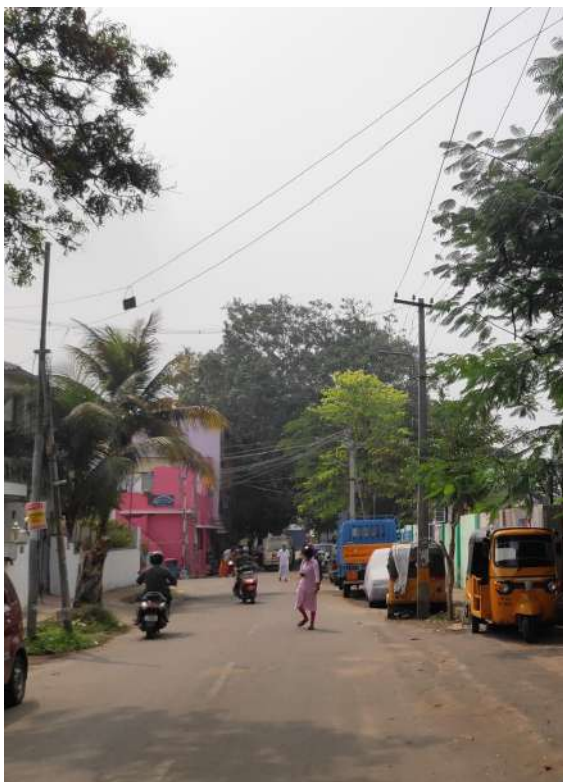
School No.	Location No.	Name of School	Location Name
16	2	CORPORATION HR SEC SCHOOL, RAMANATHAPURAM	Subramaniam St > School Entrance

- Road delineation improvement with proper signages including School Ahead sign
- Raised (table-top type) pedestrian crossing facility with proper signages and marking
- Formal and obstruction free sidewalk on both sides of the road
- Narrow (<1m wide) paved shoulder (edge line marking)

Option-2 shows the achievable star rating with zebra marking instead of raised crossing

Road Attributes	Current Situation	Improvement Option-1	Improvement Option-2
Delineation and signages	Poor	Adequate	Adequate
Paved shoulder left	Not present	Narrow	Narrow
Paved shoulder right	Not present	Narrow	Narrow
Traffic calming	Not present	Not present	Not present
Pedestrian crossing facility	No facility	Raised crossing	Marked crossing
Sidewalk left	Not present	Formal sidewalk	Formal sidewalk
Sidewalk right	Not present	Formal sidewalk	Formal sidewalk
Pedestrian fencing	Not present	Not present	Not present
Street lighting	Present	Present	Present
Road surface condition	Adequate	Adequate	Adequate
Intersection quality	NA	NA	NA
Vehicle parking	Both sides	Both sides	Both sides
STAR RATING	★ ★ ★	★ ★ ★ ★	★ ★ ★ ★ ★
Star Rating Score	31.06	6.16	9.20

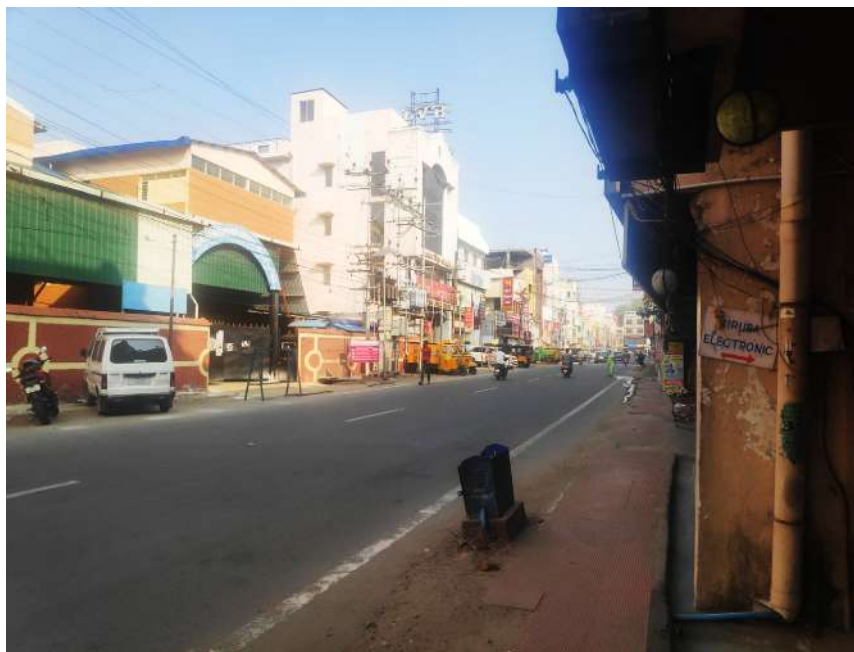
Star Rating Map

The road safety assessment of 3 locations are shown in the star rating map and details are given in the table.

Location No.	Location Name	Baseline Star Rating
1	Oppanakara Street > School Entrance	★★
2	Oppanakara Street - Edayar Street > Intersection	★
3	Oppanakara Street - Mill Rd > Intersection	★

SR4S assessment shows potential to improve pedestrian infrastructure at each of the locations. Details of existing infrastructure conditions and improvement options showing suggested safety measures and achievable star rating for each of the locations are presented in the following pages.

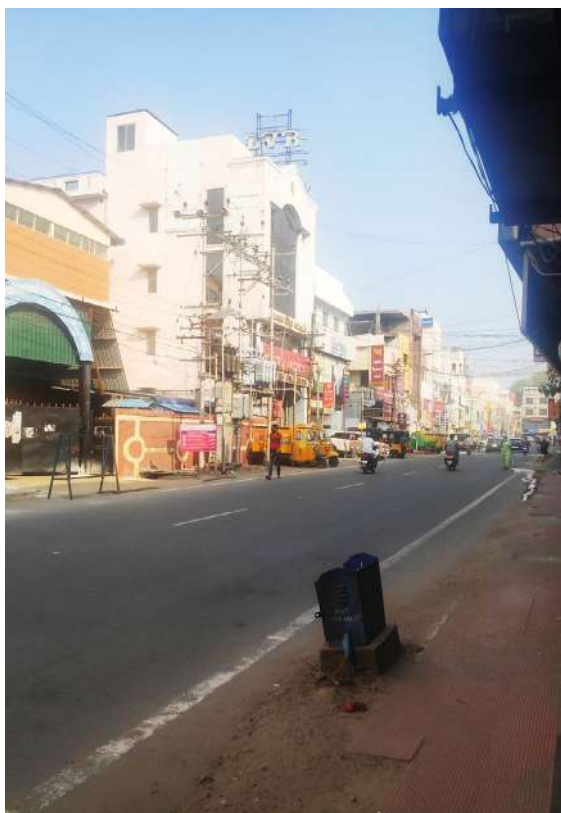
School No.	Location No.	Name of School	Location Name
17	1	CGHSS OPPANAKARA STREET	Oppanakara Street > School Entrance

- No pedestrian crossing facility
- Informal footpath (poor quality) on one side
- No speed calming measure
- One-way road

- Raised (table-top type) pedestrian crossing facility with proper signages and marking
- Formal and obstruction free sidewalk on both sides of the road
- Narrow (<1m wide) paved shoulder (edge line marking)
- School Ahead sign

Road Attributes	Current Situation	Improvement Option-1	Improvement Option-2
Delineation and signages	Adequate	Adequate	Adequate
Paved shoulder right	Narrow	Narrow	Narrow
Paved shoulder left	Not present	Narrow	Narrow
Traffic calming	Not present	Present	Not present
Pedestrian crossing facility	No facility	Raised crossing	Marked crossing
Sidewalk left	Informal sidewalk	Formal sidewalk	Formal sidewalk
Sidewalk right	Not present	Formal sidewalk	Formal sidewalk
Pedestrian fencing	Not present	Not present	Not present
Street lighting	Present	Present	Present
Road surface condition	Adequate	Adequate	Adequate
Intersection quality	NA	NA	NA
Vehicle parking	One side	One side	One side
STAR RATING	★★	★★★★	★★
Star Rating Score	62.08	11.11	62.03

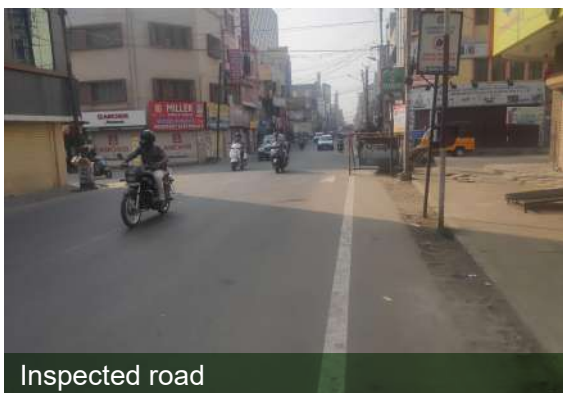
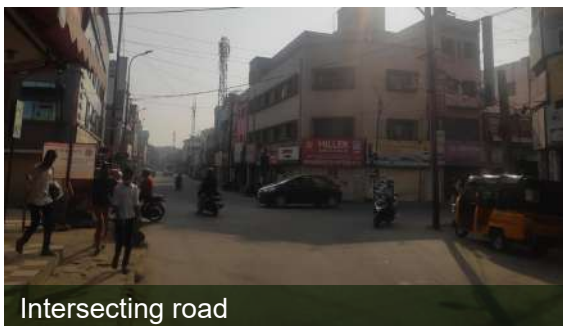
Inspected road

- No pedestrian crossing facility
- Footpath on one side
- No speed calming measure
- One-way road
- 4-leg intersection
- Poor road delineation and signages

Road Attributes	Current Situation	Improvement Option-1	Improvement Option-2
Delineation and signages	Poor	Adequate	Adequate
Paved shoulder right	Not present	Narrow	Narrow
Paved shoulder left	Not present	Narrow	Narrow
Traffic calming	Not present	Present	Not present
Pedestrian crossing facility	No facility	Raised crossing	Marked crossing
Sidewalk left	Not present	Formal sidewalk	Formal sidewalk
Sidewalk right	Formal sidewalk	Formal sidewalk	Formal sidewalk
Pedestrian fencing	Not present	Not present	Not present
Street lighting	Present	Present	Present
Road surface condition	Adequate	Adequate	Adequate
Intersection quality	Poor	Good	Good
Vehicle parking	Not present	Not present	Not present
STAR RATING	★	★★★	★
Star Rating Score	153.25	27.60	179.89

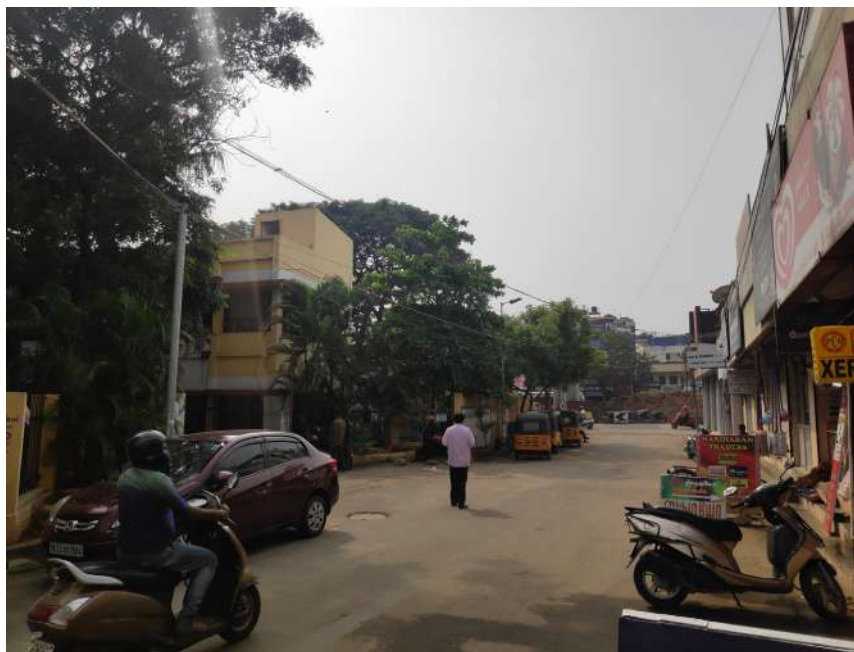
Star Rating Map

The road safety assessment of 3 locations are shown in the star rating map and details are given in the table.

Location No.	Location Name	Baseline Star Rating
1	Trichy Rd - Street Number 47 > Intersection	★
2	Street Number 47 > School Entrance	★★
3	Street Number 47 - Narayanan Street > Intersection	★★

SR4S assessment shows potential to improve pedestrian infrastructure at each of the locations. Details of existing infrastructure conditions and improvement options showing suggested safety measures and achievable star rating for each of the locations are presented in the following pages.

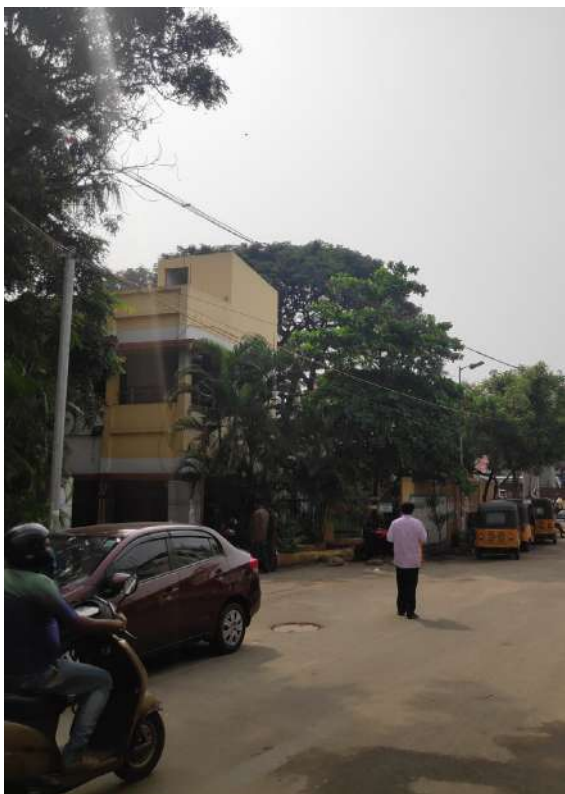
School No.	Location No.	Name of School	Location Name
18	2	CORPORATION GIRLS HSS RAMAKRISHNAPURAM	Street Number 47 > School Entrance

- Road delineation improvement with proper signages including School Ahead sign
- Raised (table-top type) pedestrian crossing facility with proper signages and marking
- Formal and obstruction free sidewalk on both sides of the road
- Narrow (<1m wide) paved shoulder (edge line marking)

Option-2 shows the achievable star rating with zebra marking instead of raised crossing

Road Attributes	Current Situation	Improvement Option-1	Improvement Option-2
Delineation and signages	Poor	Adequate	Adequate
Paved shoulder right	Not present	Narrow	Narrow
Paved shoulder left	Not present	Narrow	Narrow
Traffic calming	Not present	Present	Not present
Pedestrian crossing facility	No facility	Raised crossing	Marked crossing
Sidewalk left	Not present	Formal sidewalk	Formal sidewalk
Sidewalk right	Not present	Formal sidewalk	Formal sidewalk
Pedestrian fencing	Not present	Not present	Not present
Street lighting	Present	Present	Present
Road surface condition	Adequate	Adequate	Adequate
Intersection quality	NA	NA	NA
Vehicle parking	Both sides	Both sides	Both sides
STAR RATING	★ ★	★ ★ ★ ★	★ ★ ★
Star Rating Score	88.1	11.46	21.44

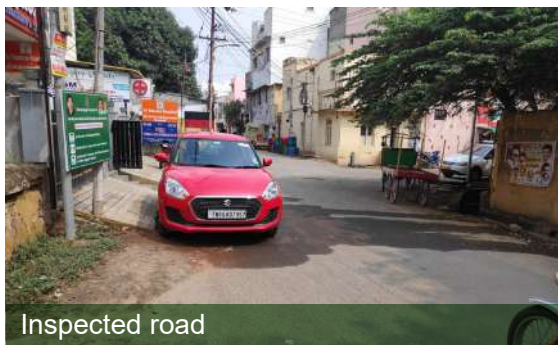
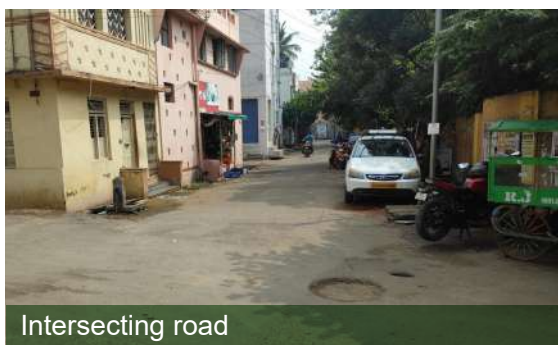
Inspected road

- No pedestrian crossing facility
- No footpath
- speed calming measures present
- Undivided road with centre-line median
- 3-leg intersection
- Moderate road surface condition
- Poor road delineation and signages

Road Attributes	Current Situation	Improvement Option-1	Improvement Option-2
Delineation and signages	Poor	Adequate	Adequate
Paved shoulder right	Not present	Narrow	Narrow
Paved shoulder left	Not present	Narrow	Narrow
Traffic calming	Present	Present	Present
Pedestrian crossing facility	No facility	Raised crossing	Marked crossing
Sidewalk left	Not present	Formal sidewalk	Formal sidewalk
Sidewalk right	Not present	Formal sidewalk	Formal sidewalk
Pedestrian fencing	Not present	Not present	Not present
Street lighting	Present	Present	Present
Road surface condition	Moderate	Adequate	Adequate
Intersection quality	Poor	Good	Good
Vehicle parking	One side	One side	One side
STAR RATING	★	★★★	★★★
Star Rating Score	67.88	17.45	26.13

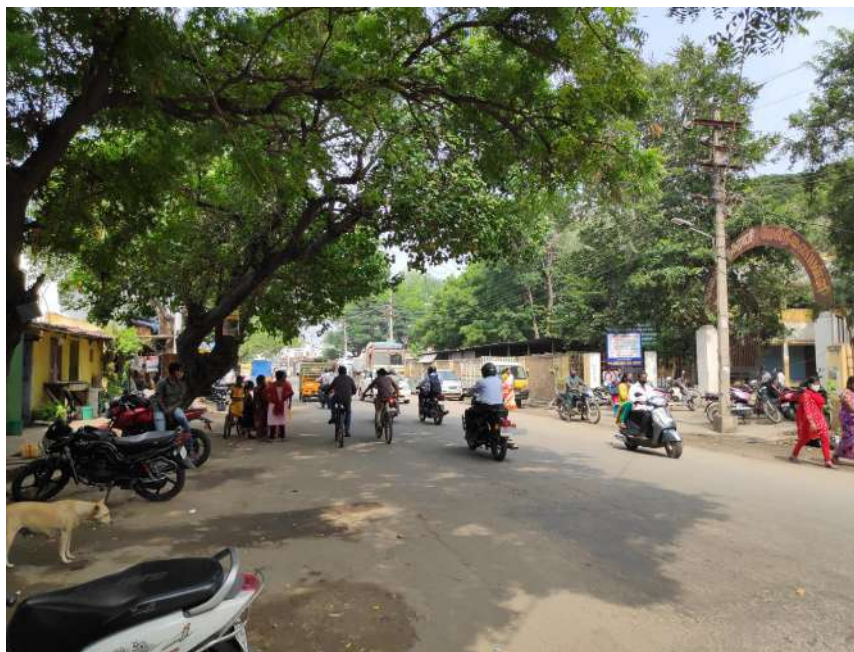
Star Rating Map

The road safety assessment of 4 locations are shown in the star rating map and details are given in the table.

Location No.	Location Name	Baseline Star Rating
1	Pioneer Mill Rd > School Entrance	★
2	Pioneer Mill Rd > Intersection	★
3	Pioneer Mill Rd – Peelamedu Railway Over Bridge> Intersection	★
4	Peelamedu Railway Over Bridge > Intersection	★

SR4S assessment shows potential to improve pedestrian infrastructure at each of the locations. Details of existing infrastructure conditions and improvement options showing suggested safety measures and achievable star rating for each of the locations are presented in the following pages.

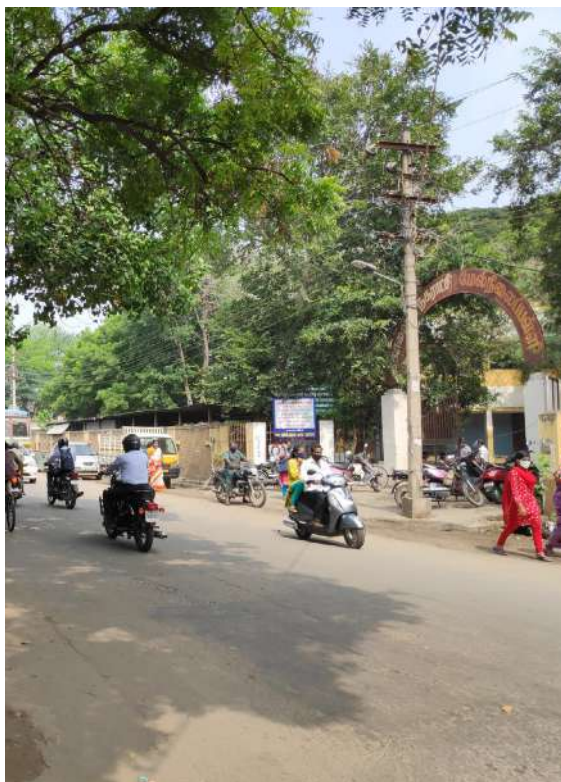
School No.	Location No.	Name of School	Location Name
19	1	CHSS, PEELAMEDU	Pioneer Mill Rd > School Entrance

- Road delineation improvement with proper signages including School Ahead sign
- Raised (table-top type) pedestrian crossing facility with proper signages and marking
- Formal and obstruction free sidewalk on both sides of the road
- Narrow (<1m wide) paved shoulder (edge line marking)

Option-2 shows the achievable star rating with zebra marking instead of raised crossing

Road Attributes	Current Situation	Improvement Option-1	Improvement Option-2
Delineation and signages	Poor	Adequate	Adequate
Paved shoulder right	Not present	Narrow	Narrow
Paved shoulder left	Not present	Narrow	Narrow
Traffic calming	Not present	Present	Not present
Pedestrian crossing facility	No facility	Raised crossing	Marked crossing
Sidewalk left	Not present	Formal sidewalk	Formal sidewalk
Sidewalk right	Not present	Formal sidewalk	Formal sidewalk
Pedestrian fencing	Not present	Not present	Not Present
Street lighting	Present	Present	Present
Road surface condition	Adequate	Adequate	Adequate
Intersection quality	NA	NA	NA
Vehicle parking	Both sides	Both sides	Both sides
STAR RATING	★	★★★★	★★★
Star Rating Score	94.01	12.77	23.87

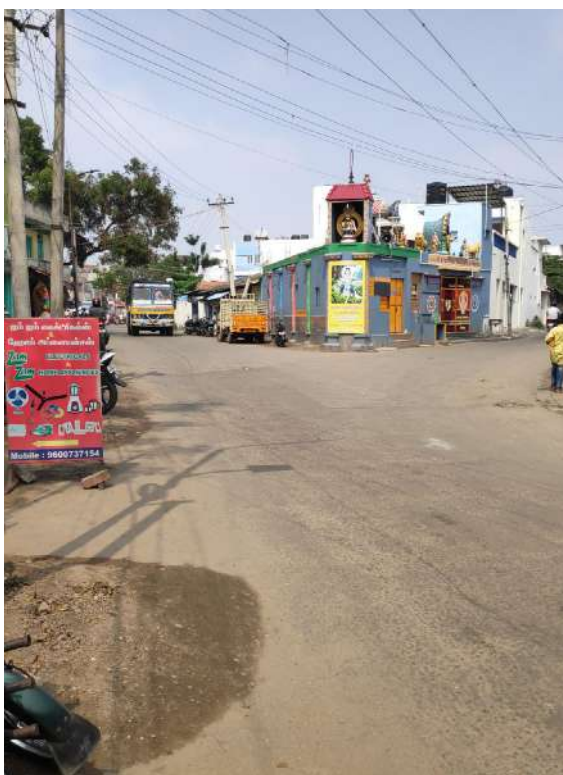
Existing Road Attributes and Improvement Options

Road Attributes	Current Situation	Improvement Option-1	Improvement Option-2
Delineation and signages	Poor	Adequate	Adequate
Paved shoulder right	Not present	Narrow	Narrow
Paved shoulder left	Not present	Narrow	Narrow
Traffic calming	Not present	Present	Not present
Pedestrian crossing facility	No facility	Raised crossing	Marked crossing
Sidewalk left	Not present	Formal sidewalk	Formal sidewalk
Sidewalk right	Not present	Formal sidewalk	Formal sidewalk
Pedestrian fencing	Not present	Not present	Not present
Street lighting	Present	Present	Present
Road surface condition	Adequate	Adequate	Adequate
Intersection quality	Poor	Good	Good
Vehicle parking	One side	One side	One side
STAR RATING	★	★★★	★★★
Star Rating Score	129.78	19.28	36.08

- Road delineation improvement with proper signages
- Raised (table-top type) pedestrian crossing facility with proper signages and marking on inspected road and intersecting road
- Formal and obstruction free sidewalk on both sides of the road
- Intersection quality improvement with proper signages and marking
- Narrow (<1m wide) paved shoulder (edge line marking)

Option-2 shows the achievable star rating with zebra marking instead of raised crossing

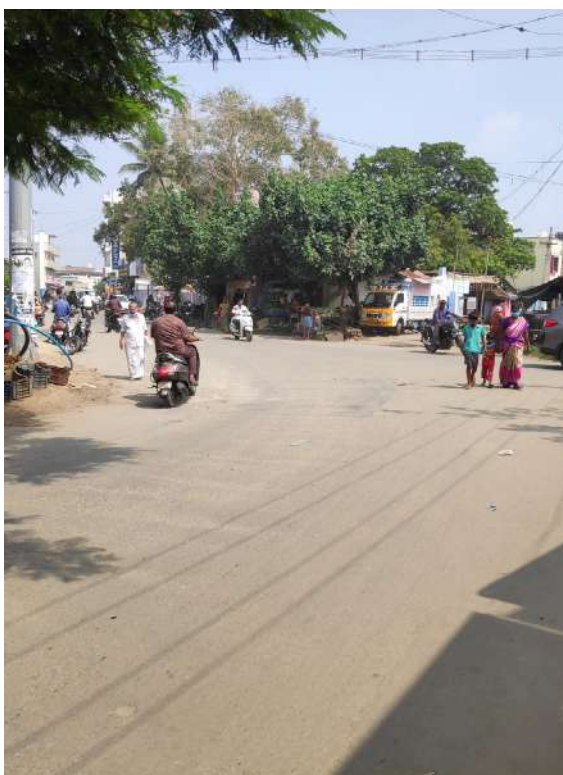
Location Description

- No pedestrian crossing facility
- No footpath
- No speed calming measure
- Undivided road with centre-line median
- Poor road delineation and signages
- 4-leg intersection
- Moderate curvature

Suggested Safety Measures (option-1)

- Road and curvature delineation improvement with proper signages
- Signalised pedestrian crossing facility with proper signages and marking on main road and raised (table-top type) crossing on intersecting road
- Formal and obstruction free sidewalk on both sides of the road
- Intersection quality improvement with proper signages and marking
- Medium (1-2.4m wide) paved shoulder (edge line marking)

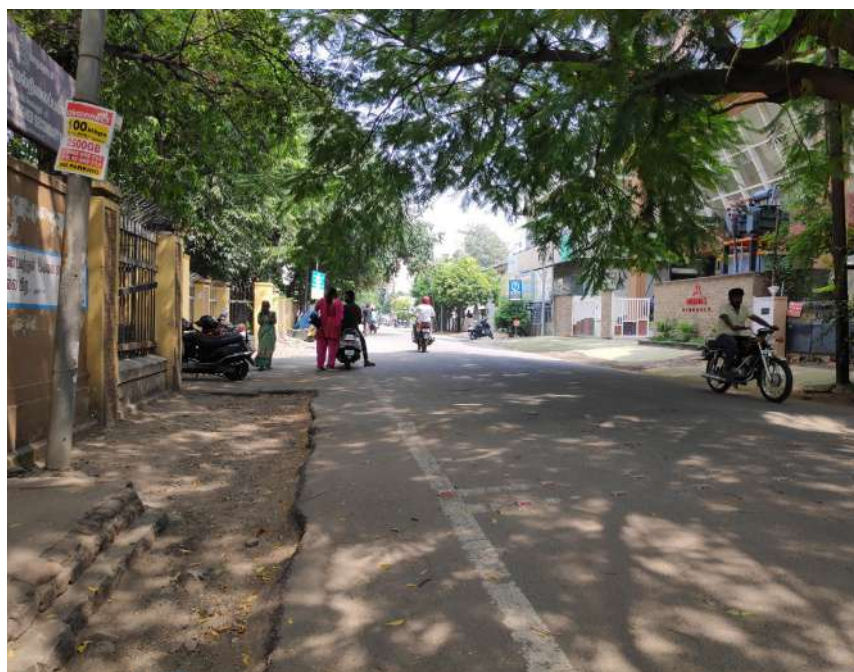
Star Rating Map

The road safety assessment of 4 locations are shown in the star rating map and details are given in the table.

Location No.	Location Name	Baseline Star Rating
1	W Sambandam Road > W Sambandam Road - Azad Road Junction	★
2	W Sambandam Road > W Sambandam Road - Sir CV Raman Road Junction	★
3	W Sambandam Road > School Entrance	★★★
4	W TV Swamy Rd - Azad Rd > Intersection	★

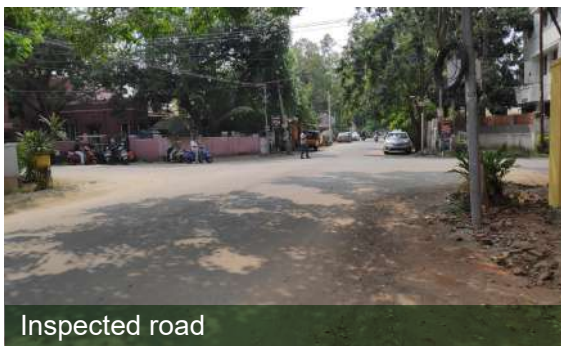
Inspected road

Location Description

- No pedestrian crossing facility
- No footpath
- No speed calming measure
- Undivided road with centre-line median
- 4-leg intersection
- Poor road delineation and signages

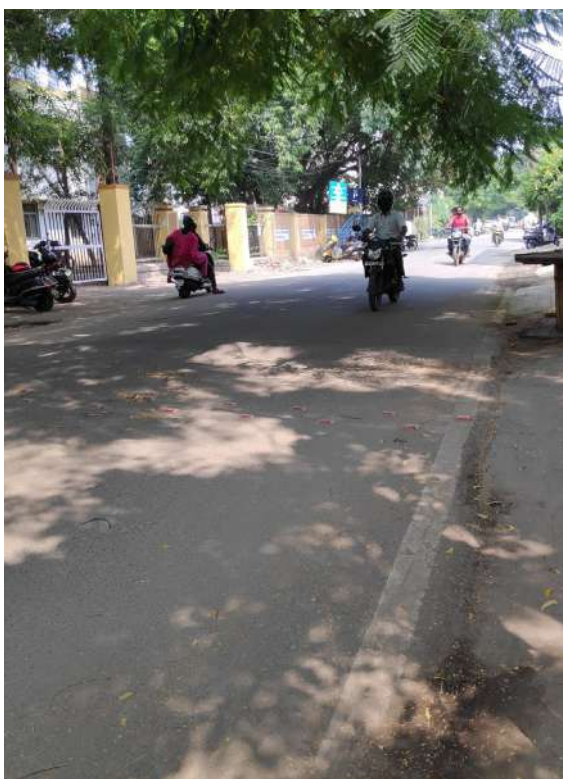
Location Description

- No pedestrian crossing facility
- No footpath
- Speed calming measure present
- Undivided road with centre-line median
- Poor road surface condition
- Poor road delineation and signages

Suggested Safety Measures (option-1)

- Road surface and delineation improvement with proper signages including School Ahead sign
- Raised (table-top type) pedestrian crossing facility with proper signages and marking
- Formal and obstruction free sidewalk on both sides of the road

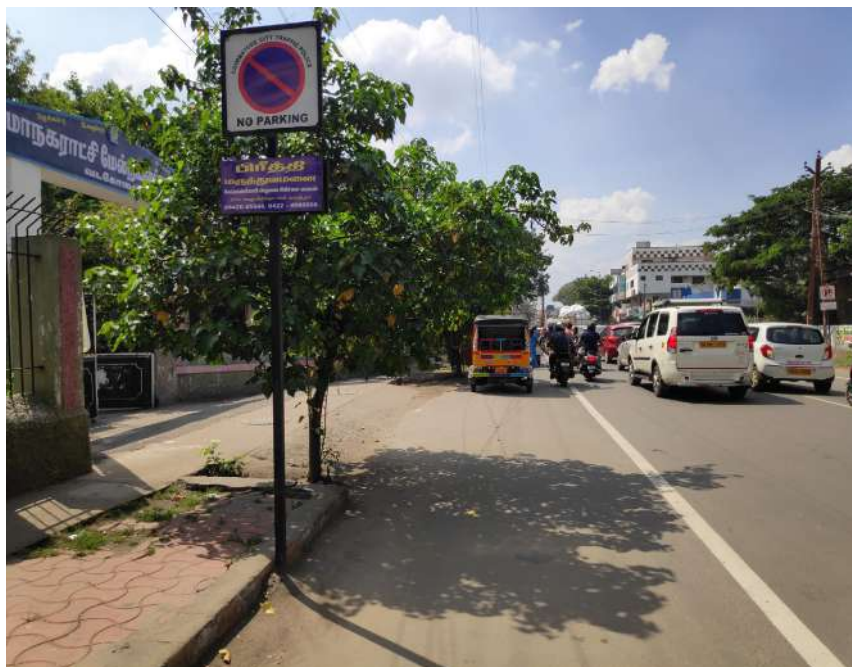
Star Rating Map

Location No.	Location Name	Baseline Star Rating
1	Cross Cut Rd > School Entrance	★ ★
2	Cross Cut Rd - E Power House Rd > Intersection	★ ★
3	Cross Cut Rd - Swarnambika Rd > Intersection	★ ★

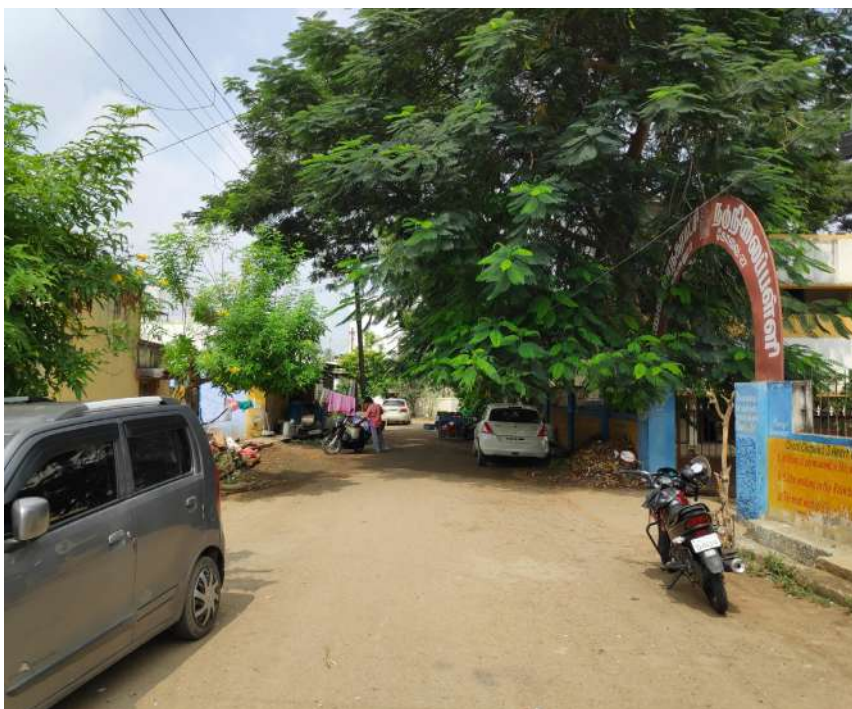
Star Rating Map

The road safety assessment of 4 locations are shown in the star rating map and details are given in the table.

Location No.	Location Name	Baseline Star Rating
1	School Road > School Entrance	★ ★ ★
2	Sanganoor Rd - School Road > Intersection	★ ★
3	Sanganoor Main Rd - Sanganoor Road > Intersection	★
4	Sanganoor Main Rd - Samy Gounder St > Intersection	★

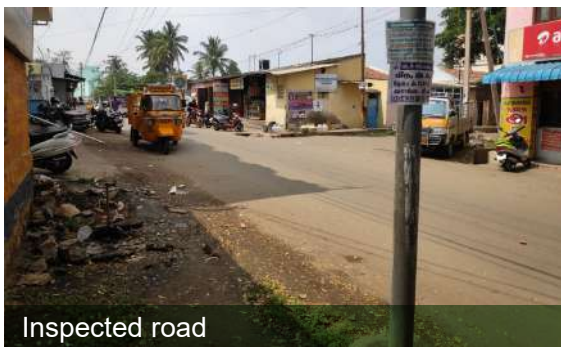
Inspected road

Location Description

- No pedestrian crossing facility
- No footpath
- No speed calming measure
- Undivided road with centre-line median
- 3-leg intersection
- Poor road delineation and signages

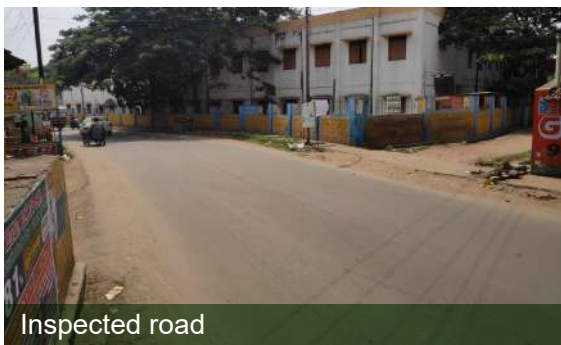
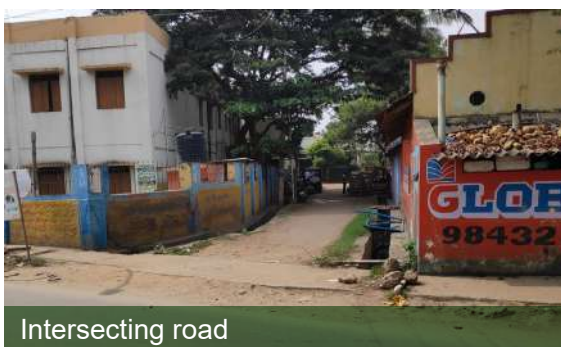
Location Description

- No pedestrian crossing facility
- No footpath
- No speed calming measure
- Undivided road with centre-line median
- 3-leg intersection
- Poor road delineation and signages

Suggested Safety Measures (option-1)

- Road and curvature delineation improvement with proper signages including chevron sign
- Raised (table-top type) pedestrian crossing facility with proper signages and marking on inspected road and intersecting road
- Formal and obstruction free sidewalk on both sides of the road
- Intersection quality improvement with proper signages and marking
- Narrow (<1m wide) paved shoulder (edge line marking)

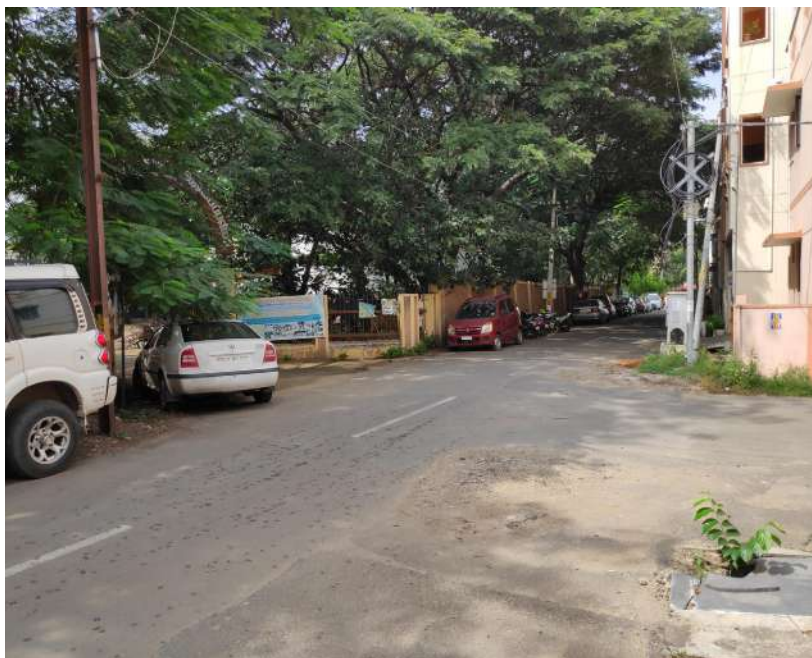
Star Rating Map

The road safety assessment of 3 locations are shown in the star rating map and details are given in the table.

Location No.	Location Name	Baseline Star Rating
1	School Road > School entrance - Intersection	★ ★ ★
2	Bharathi Park Rd > Intersection	★
3	Bharathi Park Rd Number 2 > Intersection	★ ★

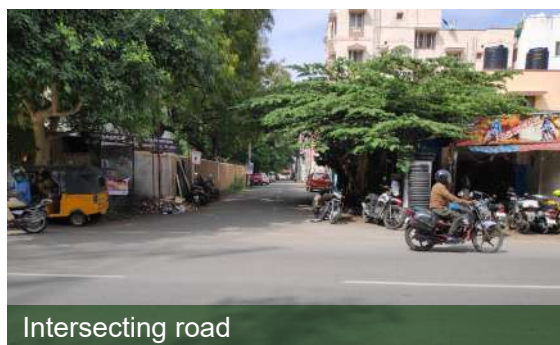
Intersecting road

- No pedestrian crossing facility
- No footpath
- No speed calming measure
- Undivided road with centre-line median
- 3-leg intersection
- Moderate road surface condition
- Poor road delineation and signages

- Road surface and delineation improvement with proper signages including School Ahead sign
- Raised (table-top type) pedestrian crossing facility with proper signages and marking on inspected road and intersecting road
- Formal and obstruction free sidewalk on both sides of the road
- Intersection quality improvement with proper signages and marking
- Narrow (<1m wide) paved shoulder (edge line marking)

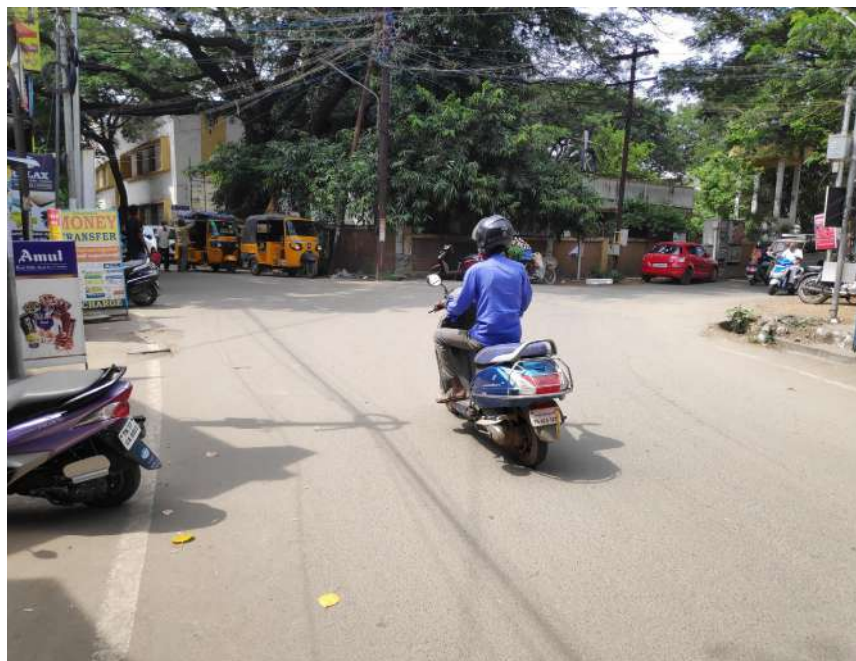
Star Rating Map

The road safety assessment of 2 locations are shown in the star rating map and details are given in the table.

Location No.	Location Name	Baseline Star Rating
1	Parameshwaran Layout Rd - Bharathiyar Rd > Intersection	★
2	Bharathiyar Rd - Rangammal Kovil St > Intersection	★★

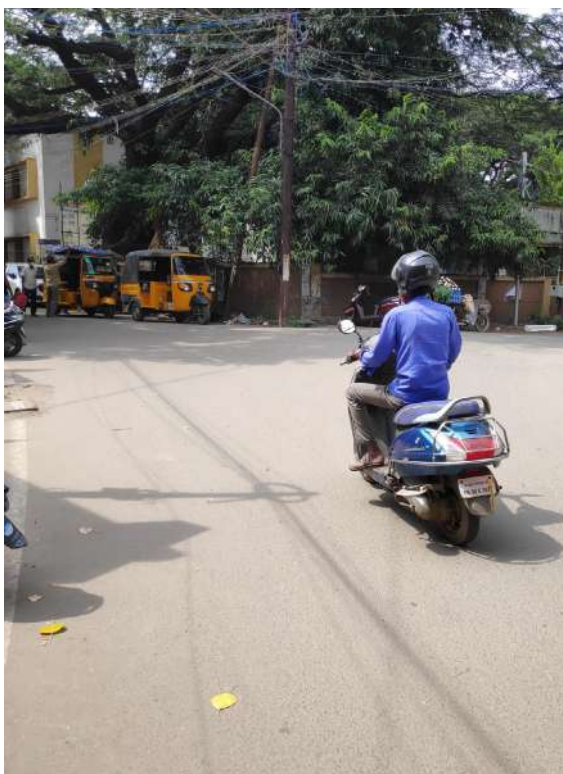
- No pedestrian crossing facility
- No footpath
- No speed calming measure
- Undivided road with centre-line median
- 3-leg intersection
- Moderate curvature
- Poor road delineation and signages

- Road and curvature delineation improvement with proper signages including, chevron sign, School Ahead sign etc.
- Raised (table-top type) pedestrian crossing facility with proper signages and marking on inspected road and intersecting road
- Formal and obstruction free sidewalk on both sides of the road
- Intersection quality improvement with proper signages and marking

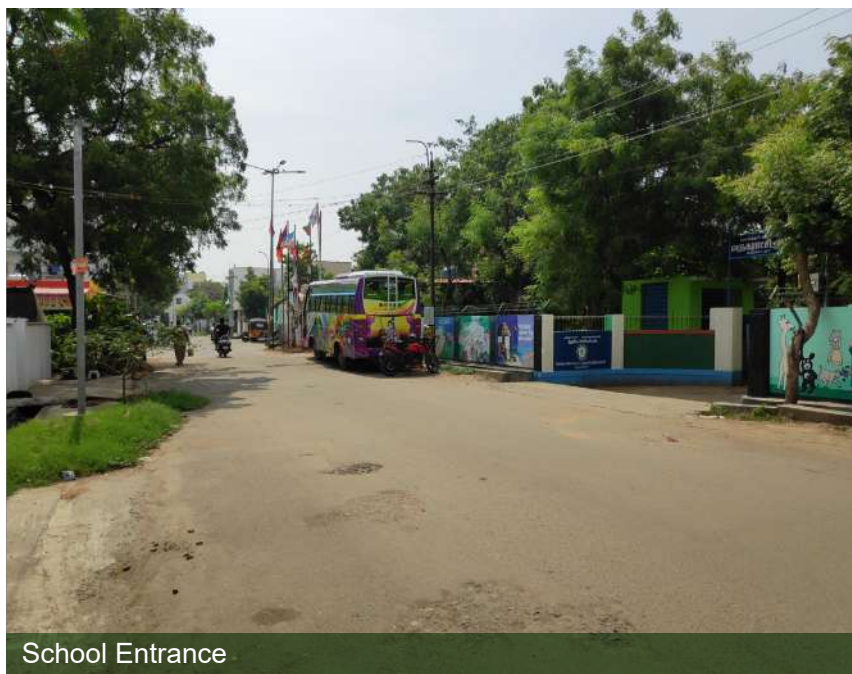
Star Rating Map

Location No.	Location Name	Baseline Star Rating
1	School Road > School Entrance	★★
2	School Road > Left Intersection	★★
3	School Road > Right Intersection	★★★
4	School Road > Intersection	★

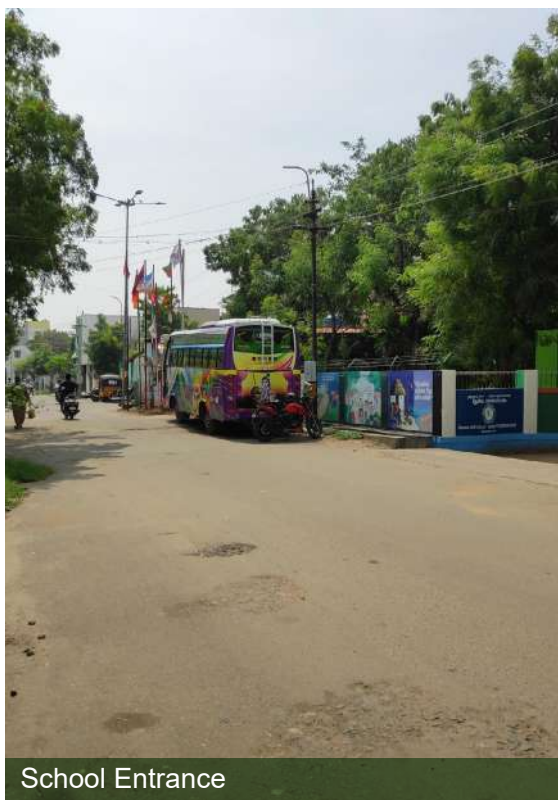
School Entrance

- No pedestrian crossing facility
- Informal footpath on one side
- No speed calming measure
- Undivided road with centre-line median
- Inadequate road delineation and signages
- Moderate road condition

- Road surface and delineation improvement with proper signages including School Ahead sign
- Marked pedestrian crossing facility with proper signages and marking (Zebra crossing)
- Formal and obstruction free sidewalk on both sides of the road
- Narrow (<1m wide) paved shoulder (edge line marking)

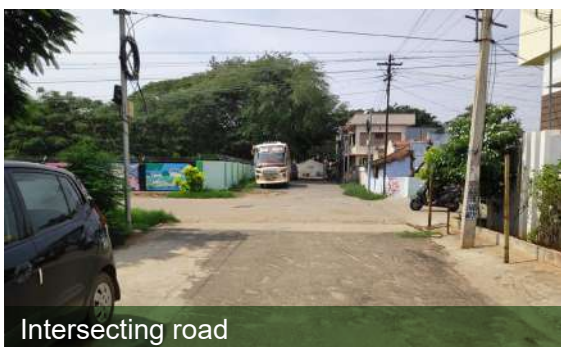
- No pedestrian crossing facility
- No footpath
- No speed calming measure
- Undivided road with centre-line median
- 4-leg intersection
- Moderate road surface condition
- Inadequate road delineation and signages

- Road surface and delineation improvement with proper signages including School Ahead sign
- Raised (table-top type) pedestrian crossing facility with proper signages and marking on inspected road and intersecting road
- Formal and obstruction free sidewalk on both sides of the road
- Intersection quality improvement with proper signages and marking
- Narrow (<1m wide) paved shoulder (edge line marking)

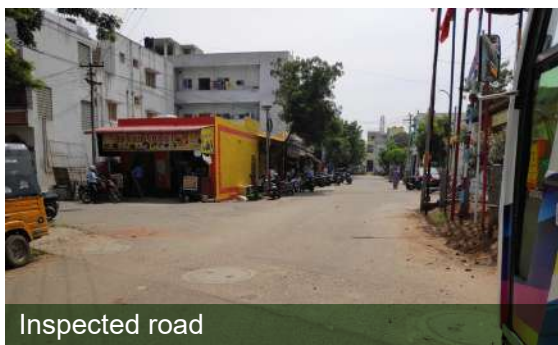
Inspected road

- No pedestrian crossing facility
- No footpath
- No speed calming measure
- Undivided road with centre-line median
- 3-leg intersection
- Inadequate road delineation and signages

- Road delineation improvement with proper signages including School Ahead sign
 - Raised (table-top type) pedestrian crossing facility with proper signages and marking on inspected road and intersecting road
 - Formal and obstruction free sidewalk on both sides of the road
 - Intersection quality improvement with proper signages and marking
 - Narrow (<1m wide) paved shoulder (edge line marking)
- Option-2 shows the achievable star rating with zebra marking instead of raised crossing*

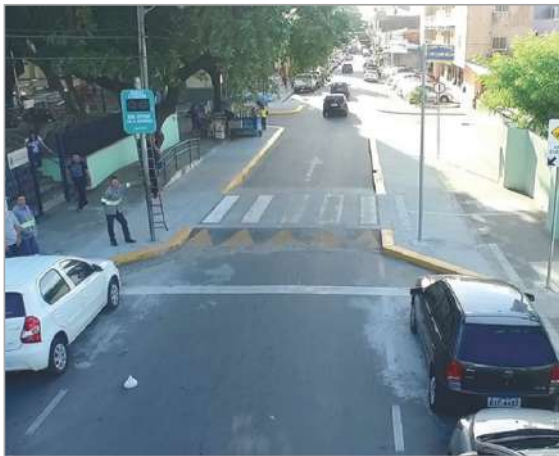
Undivided road

Unsignalized raised marked pedestrian crossing (table top type crossing) can be provided on undivided roads with medium-high pedestrian crossing demand.

This type of crossing facility acts as a speed-calming measure also reducing the risk for crossing pedestrians.

Facility should be provided with adequate signages, markings etc. and should be designed as per IRC standards (IRC:99-2018).

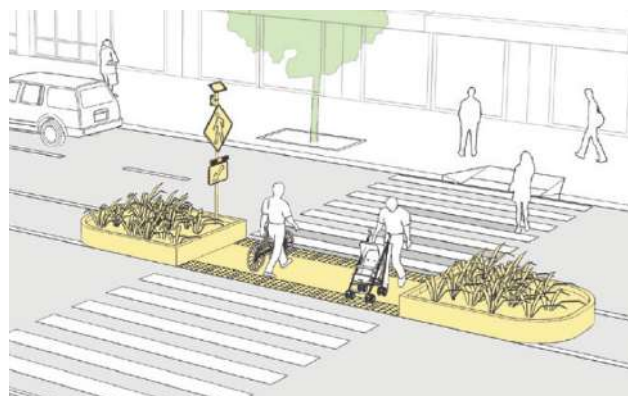
Median Refuge Island

Median refuge with good surface, adequate dimension and free of obstructions should be provided on all crossing facilities across divided roads. Raised kerb should be provided at the end of median refuge at intersections.
